Daily Field Report # 1 (Roof Condition)

Project Information:	4470 N. Shallowford Rd. Dunwoody, GA	NOVA Project Number:	10102-0516031
		Day/Date of Site Visit:	Thurs. 07-14-2016
		Weather:	Sunny, Low 90s F
Client:	Comprehensive Program Services	Roof Observer:	Michael J Wright
Client Contact & Ph:	Eric Johnson / 770-451-7670	Deck Type:	Vented Metal

TODAY'S SITE VISIT SUMMARY:

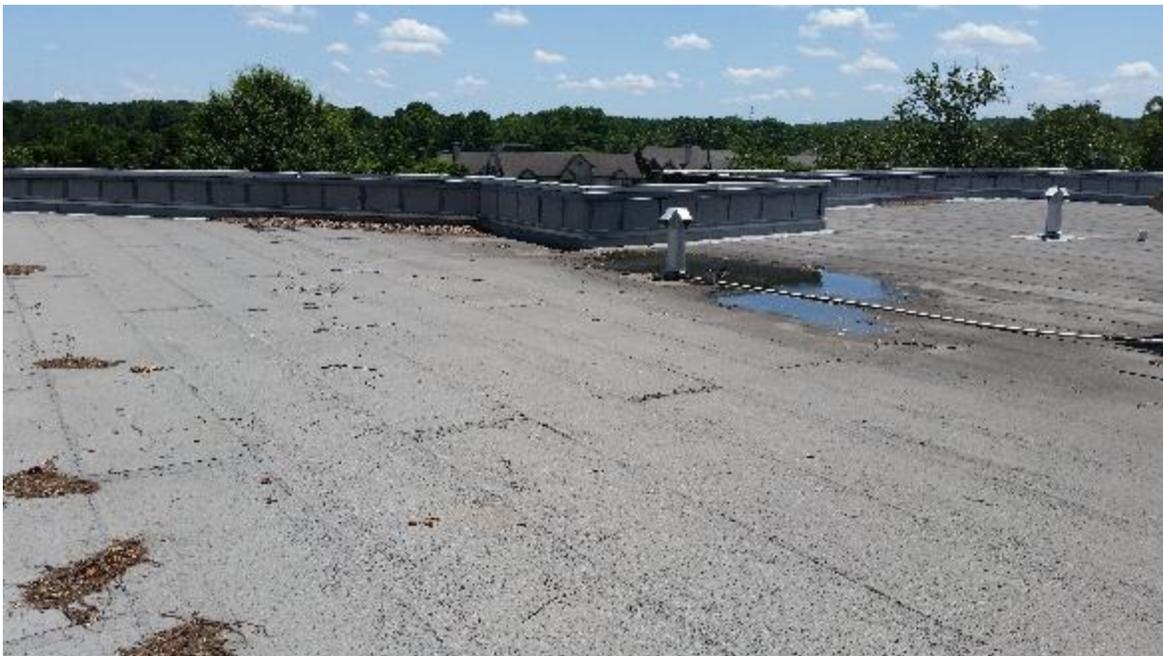
Overall view of the roof as viewed looking east

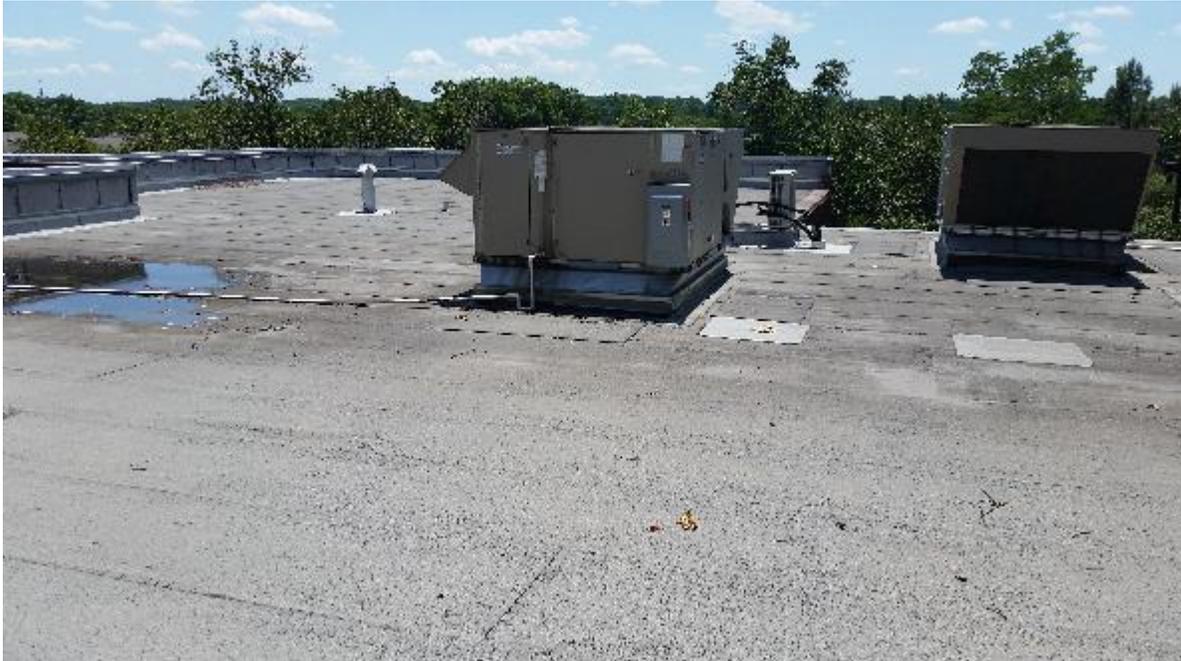
Overall view of the roof as viewed looking south

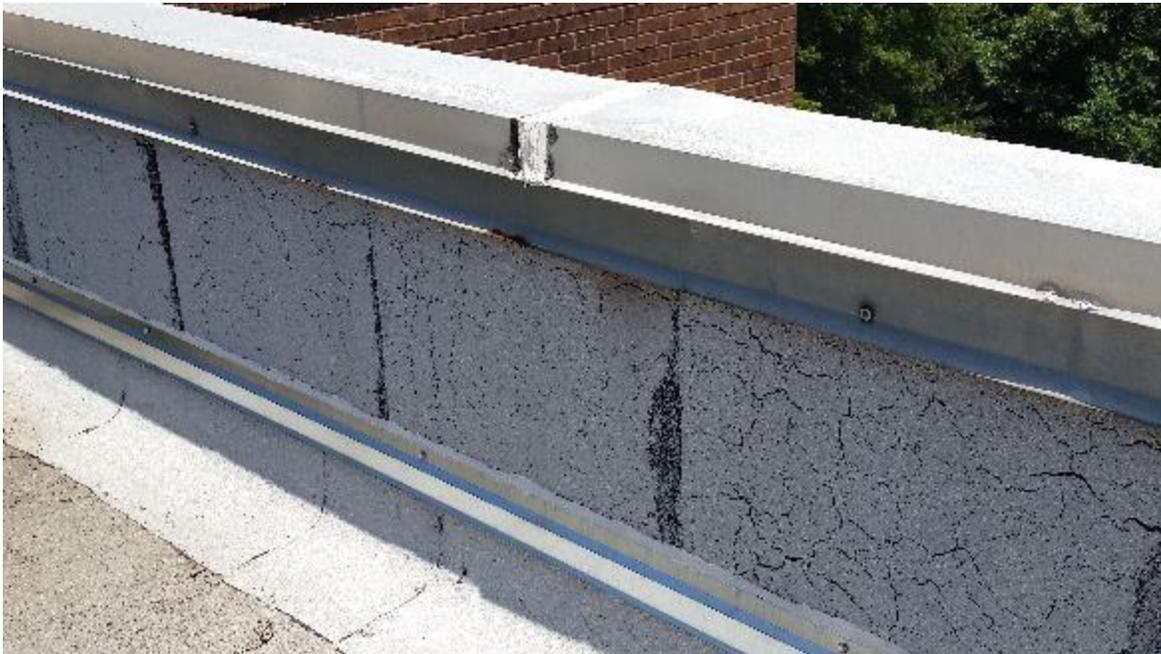
Perimeter base flashing are improperly applied/installed and exhibit severely cracked and deteriorated surface.

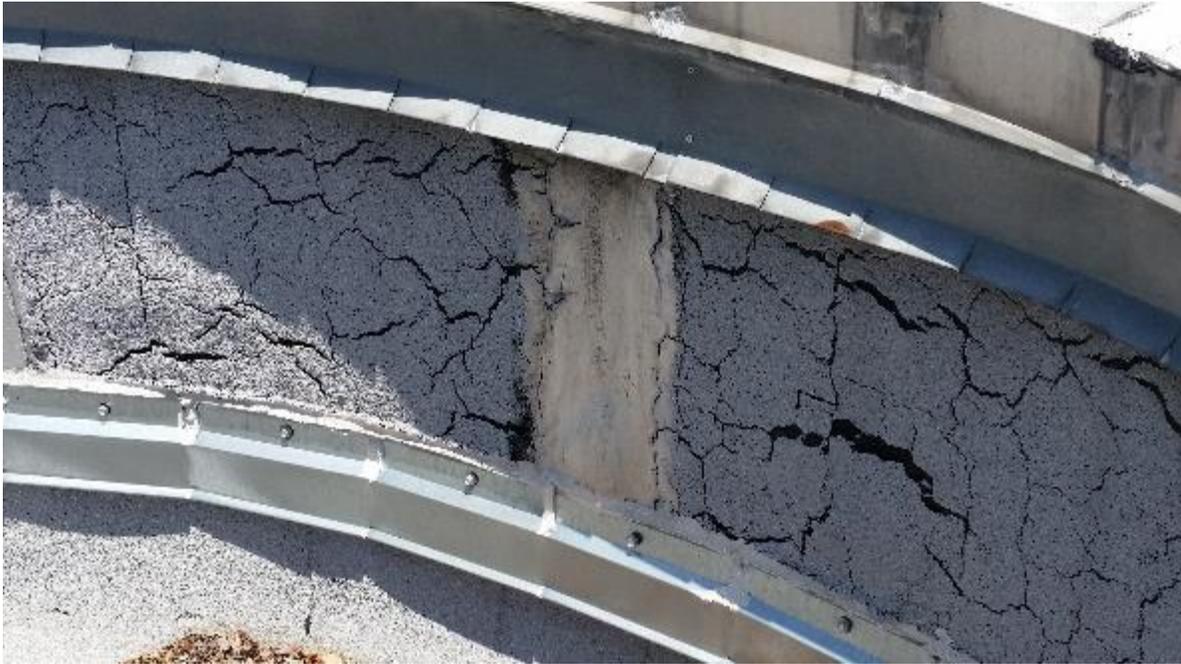
Repairs made with improper material.

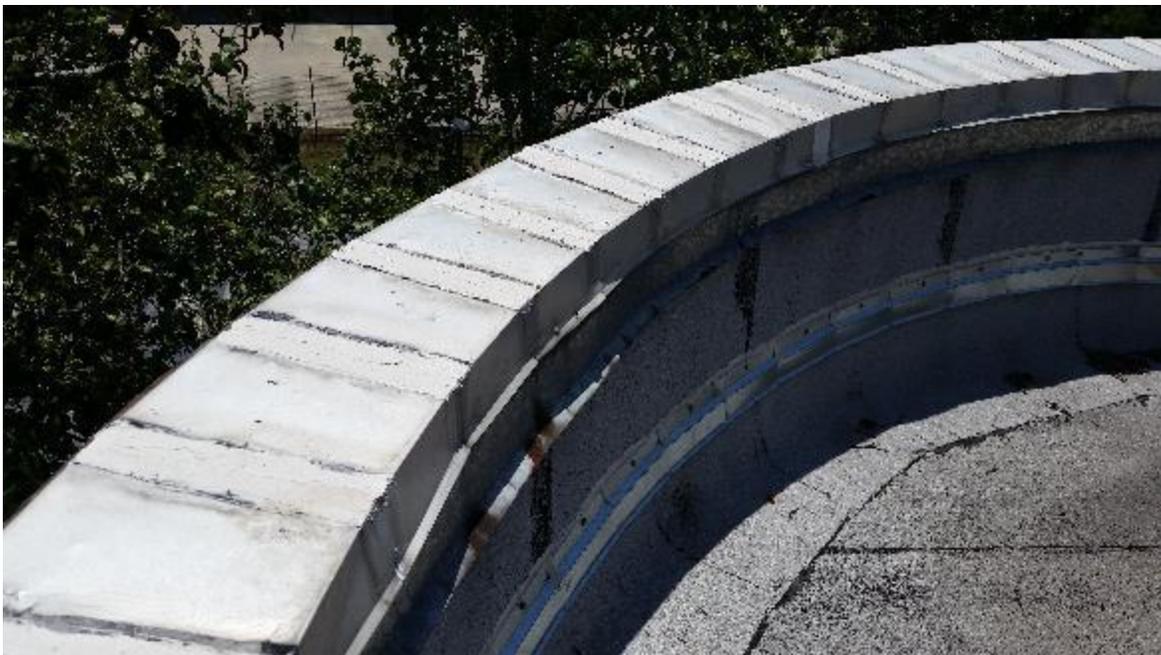
Perimeter coping was observed to have multiple inconsistent applications of sealants.

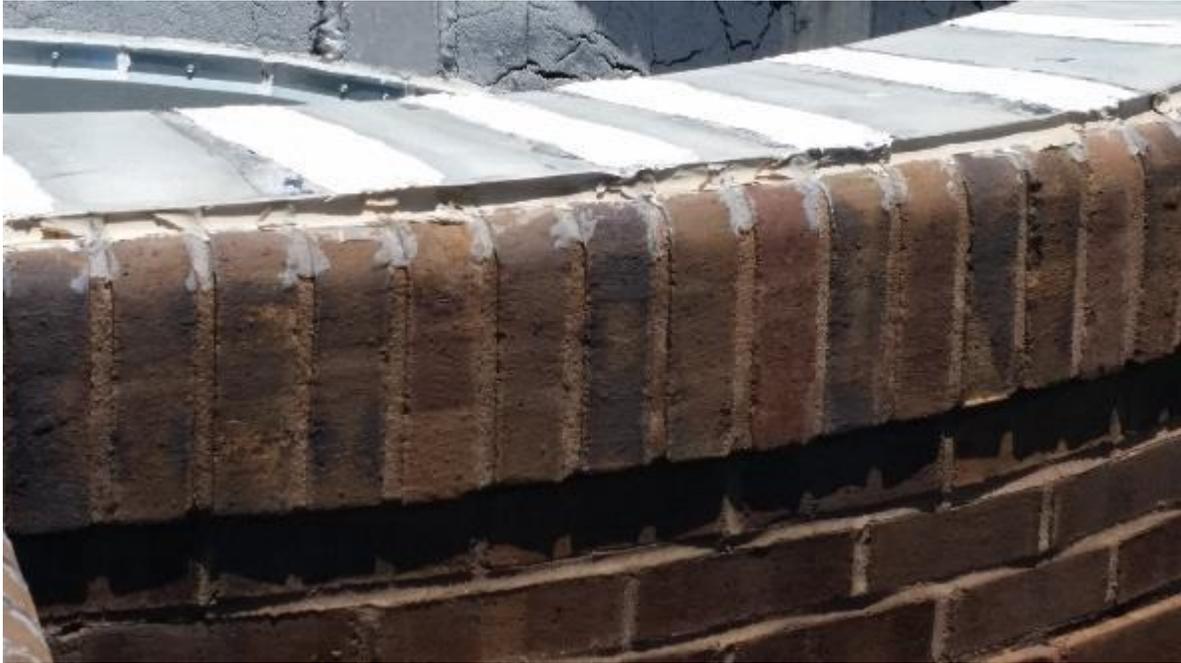
Perimeter coping was observed to have multiple inconsistent types of sealants

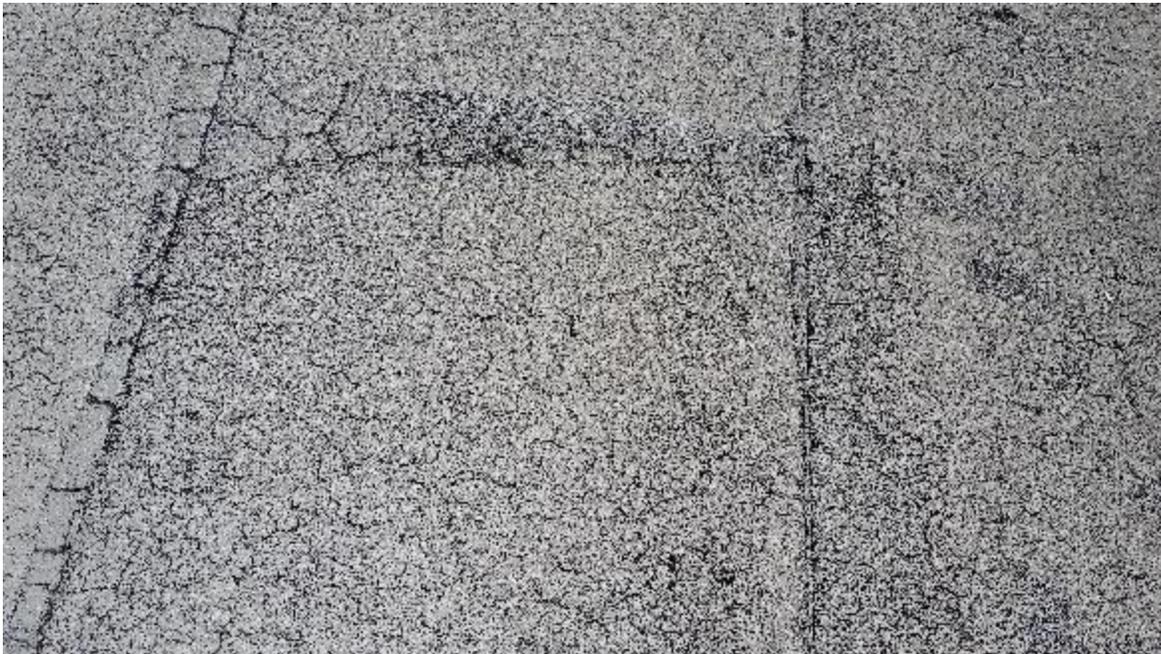
Granule surfaced membrane capsheet exhibits severe deterioration and cracking

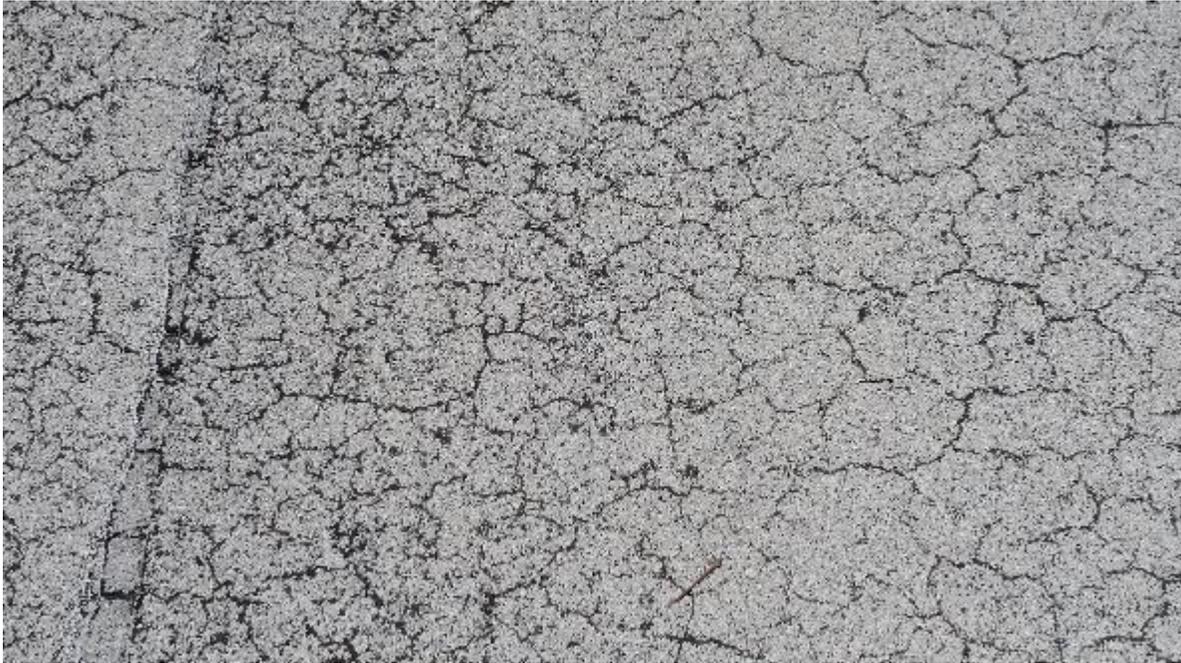
Granule surfaced membrane capsheet exhibits severe deterioration and cracking

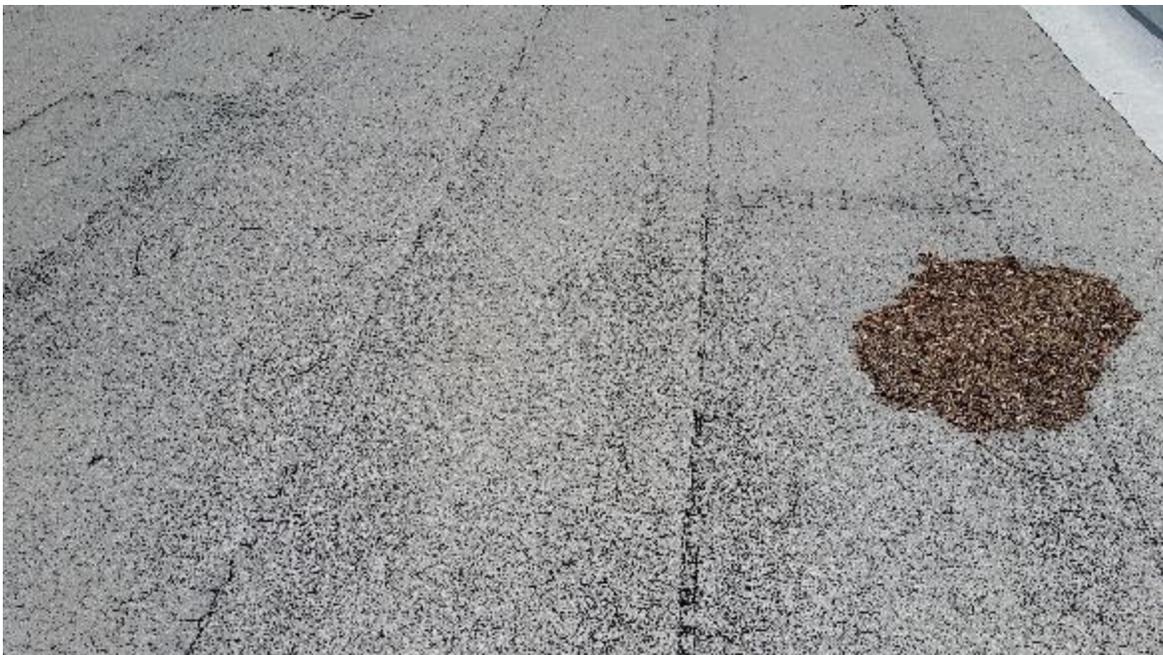
There are localized areas of trapped air, beneath the granular surfaced capsheet

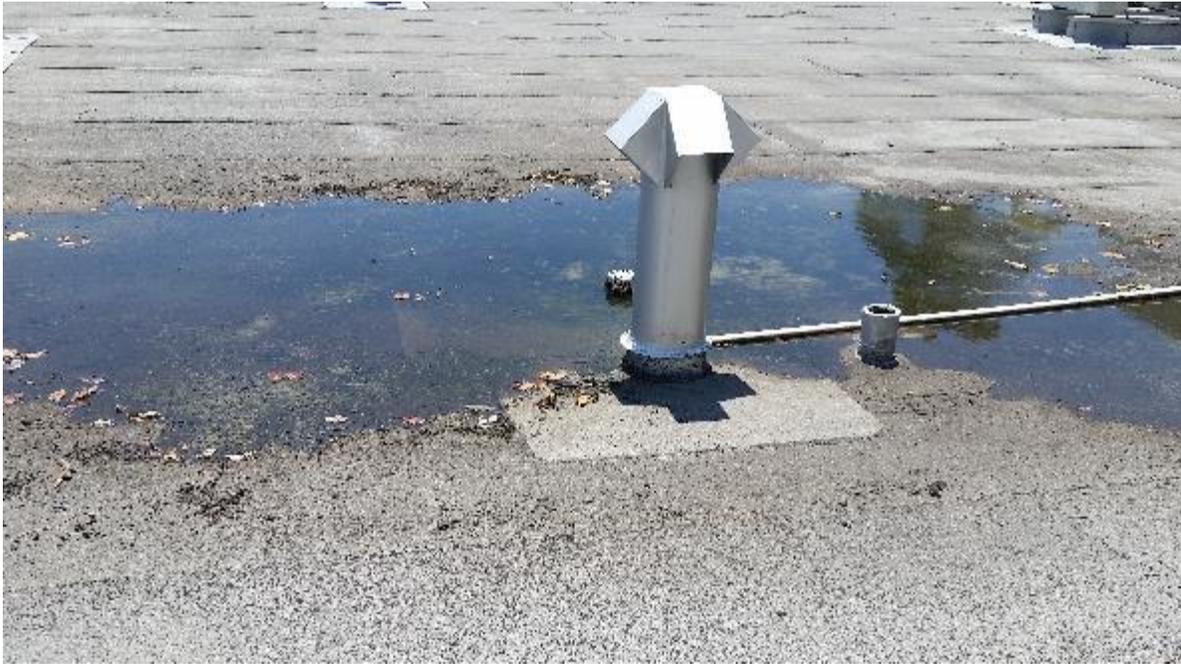
Standing water is present around the drain and sump locations

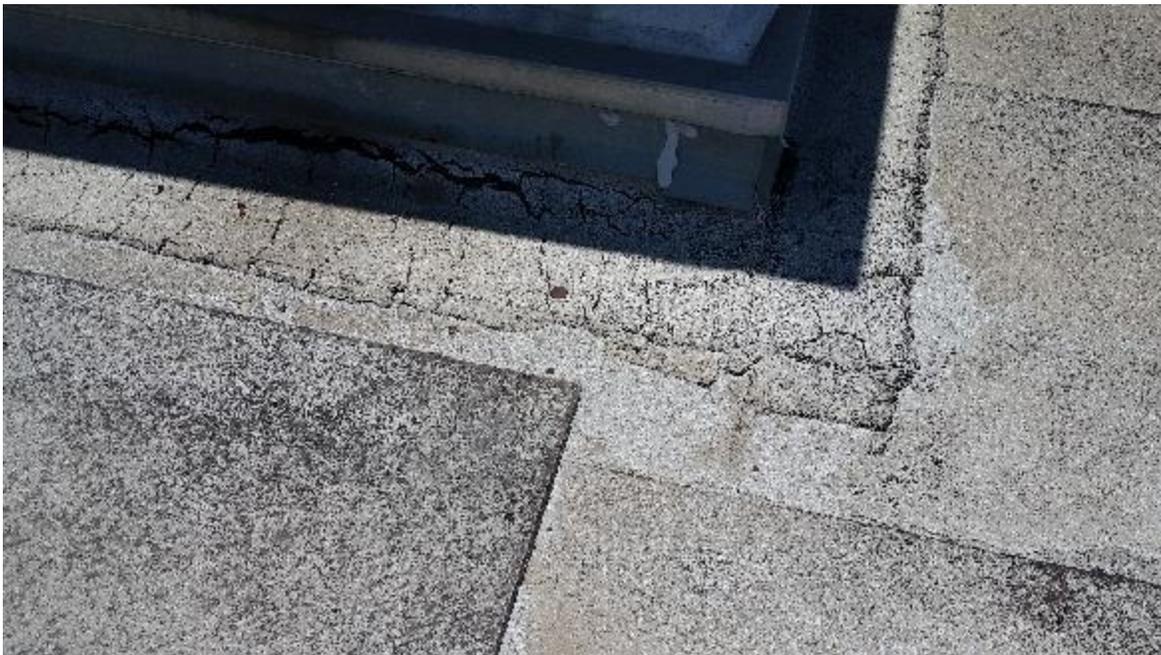
Repairs to field seams have been performed improperly and with improper repair materials

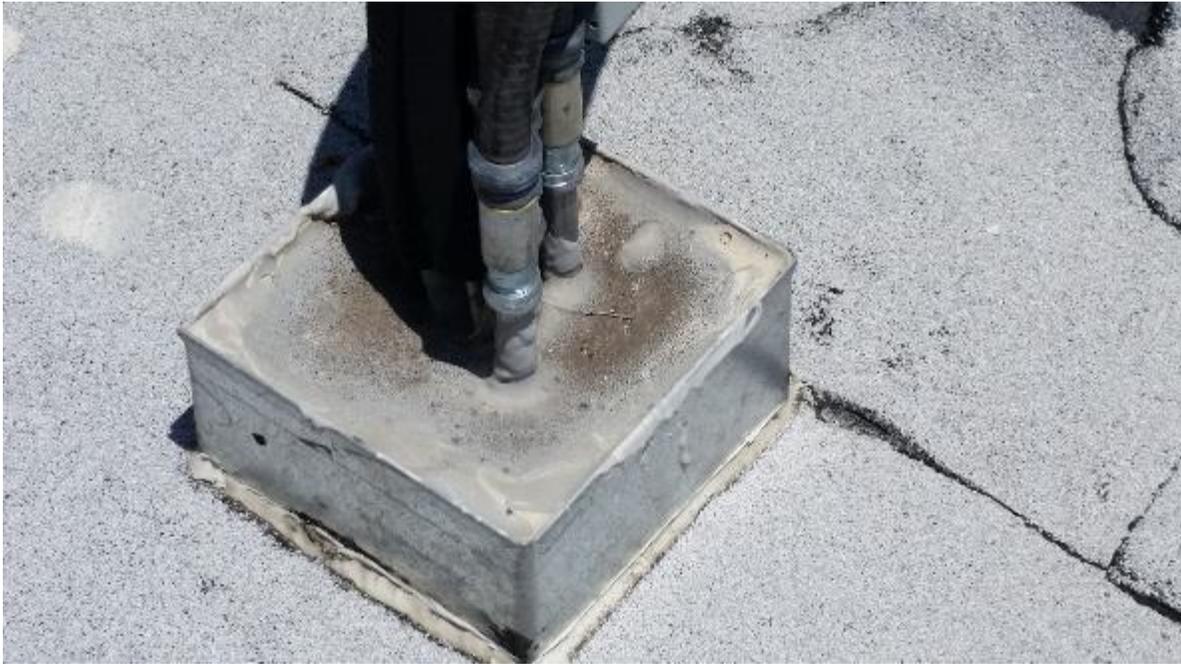
Base flashing membrane, at curb penetrations, are newer than the field membrane and have not bonded to the surface properly.

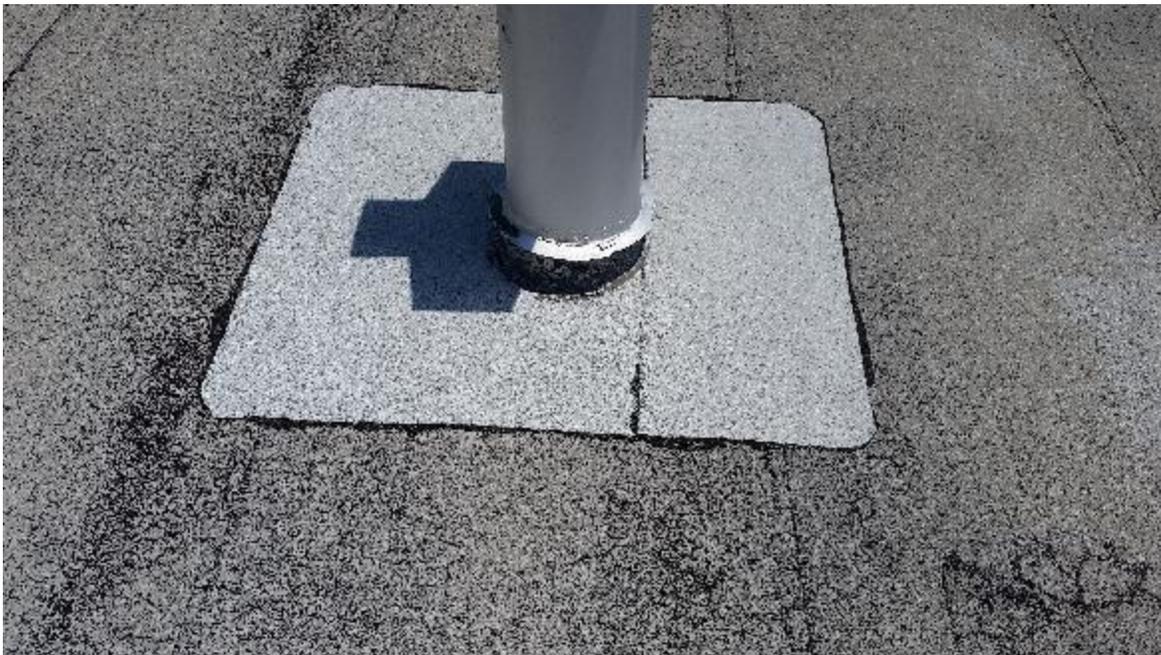
Base flashing membrane, at curb penetrations, are newer than the field membrane and have not bonded to the surface properly.

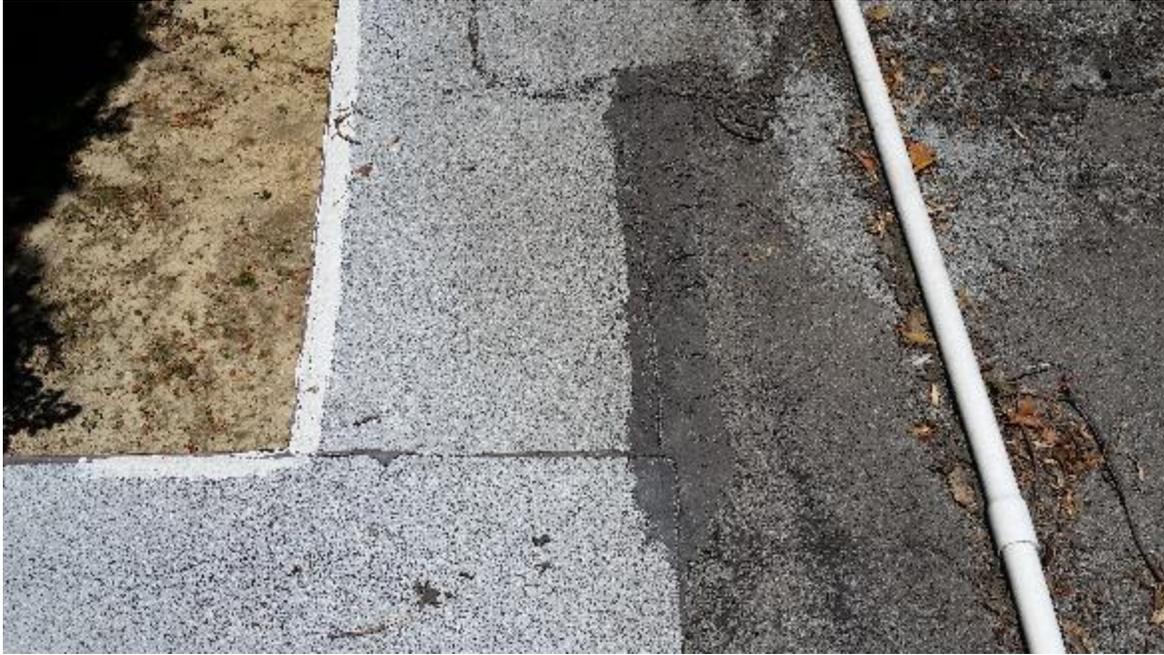
Repairs at roof edge metal have been performed with non-compatible materials

- Markings in several repair locations indicate that the roof may have had some recent repairs. These roofing materials are typically warranted for 20-25 years when properly maintained.
- Based on information from observations on the site, this roof is beyond its usable service life. NOVA recommends budgeting for roof replacement in the near future.
- NOVA recommends extracting roof core to determine roof assembly construction, insulation type and thickness, and the presence of moisture.
