ITB 14-11

ITB 14-11 Demolition of Dormitory Building at Brook Run Park

The purpose of this Invitation to Bid (ITB) is to select a qualified contractor for the demolition and removal of two (2) structures from Brook Run Park. These structures are designated as the Dorm Building and the Pump Room on the provided site plan and environmental test correspondence. The

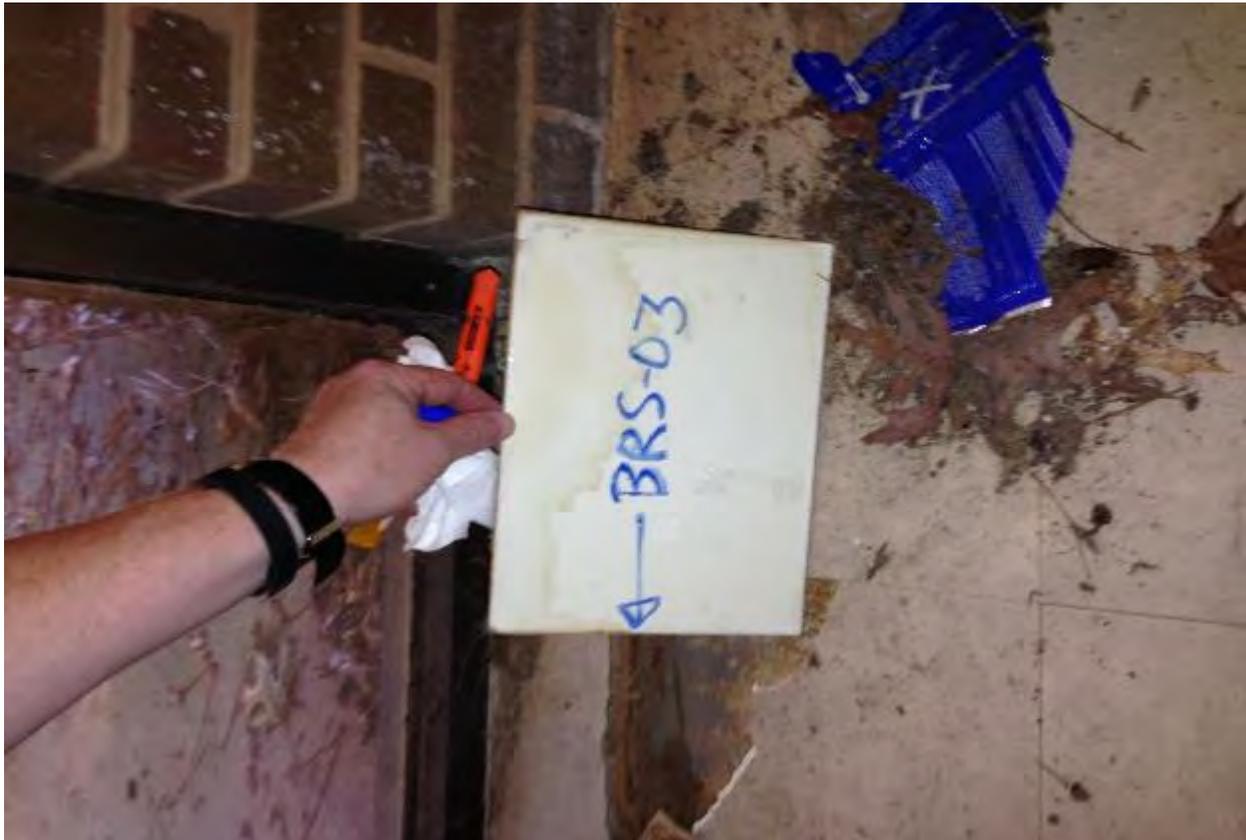
Plate 3: Laboratory analyses did not detect asbestos minerals within the floor tile or mastic sample BRS-03 collected from the South Administrative Building east room.

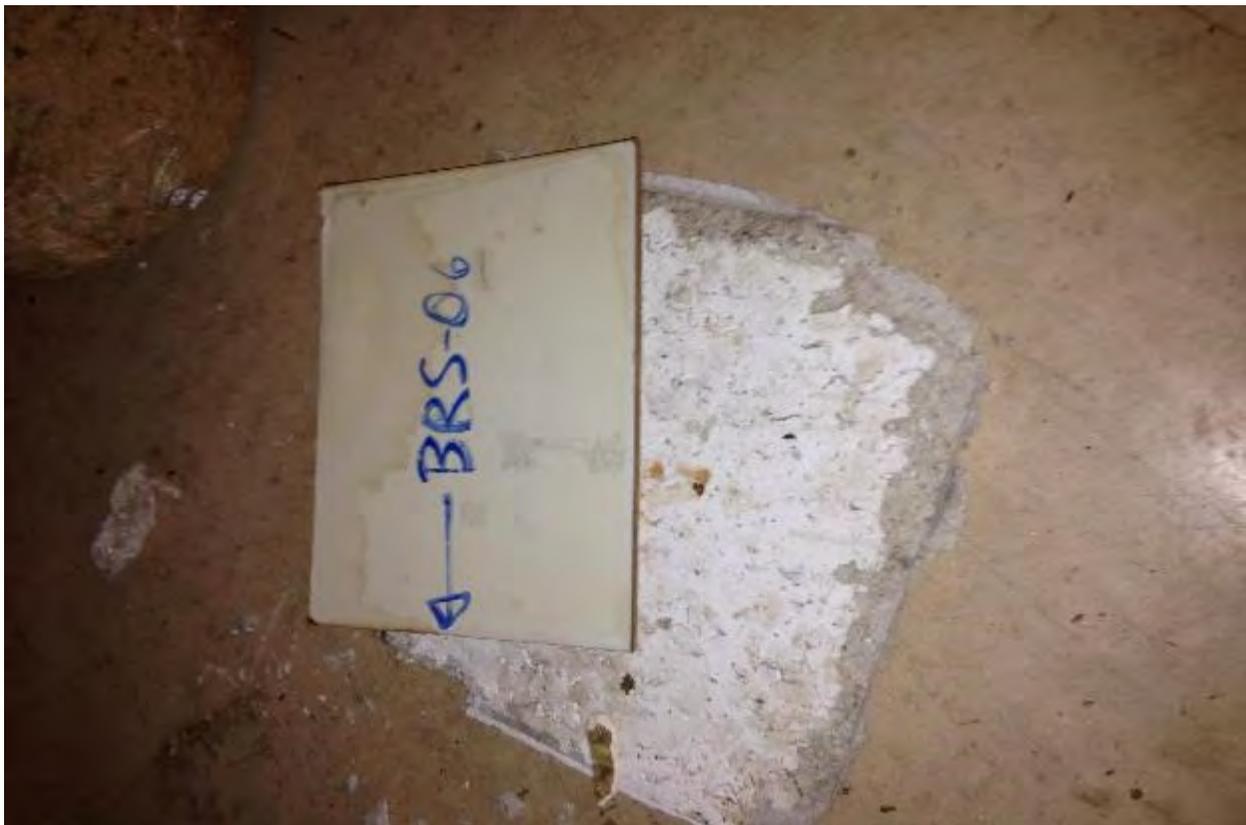
Plate 6: Laboratory analyses detected 2% chrysotile asbestos and 2% amosite asbestos within suspended ceiling tile sample BRS-06 collected from the South Administrative Building east rooms.

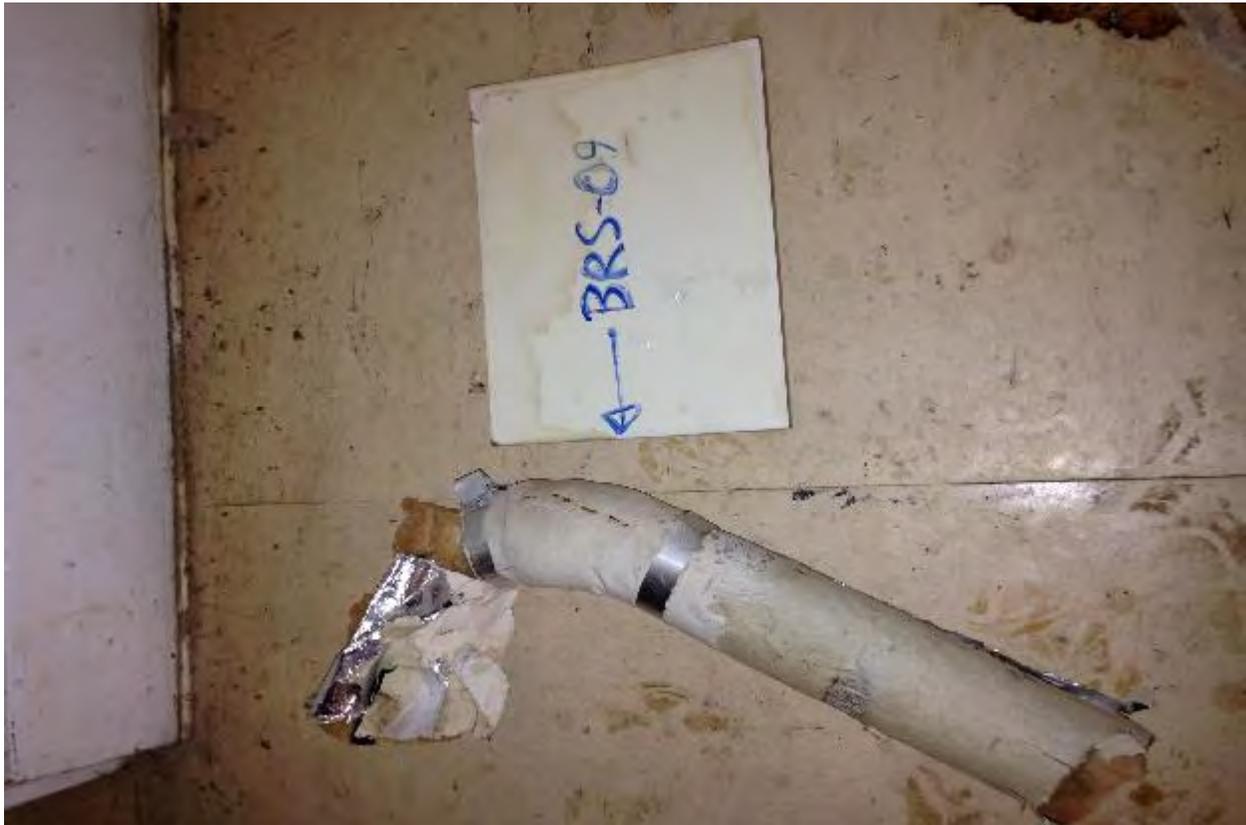
Plate 9: Laboratory analyses did not detect asbestos minerals within pipe elbow wrap sample BRS-09 collected from the South Administrative Building east rooms.

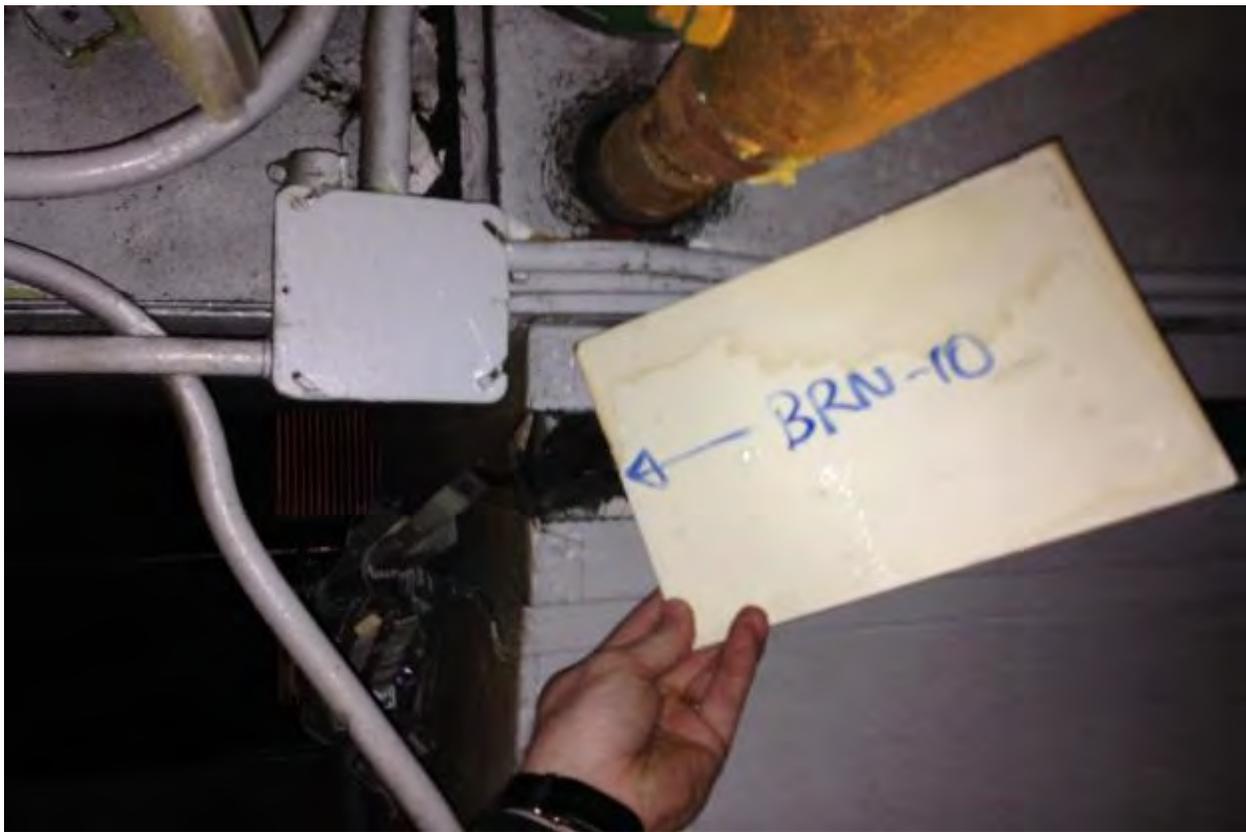
Plate 10: Laboratory analyses did not detect asbestos minerals within HVAC gasket sample BRN-10 collected from the North Administrative Building mechanical room.

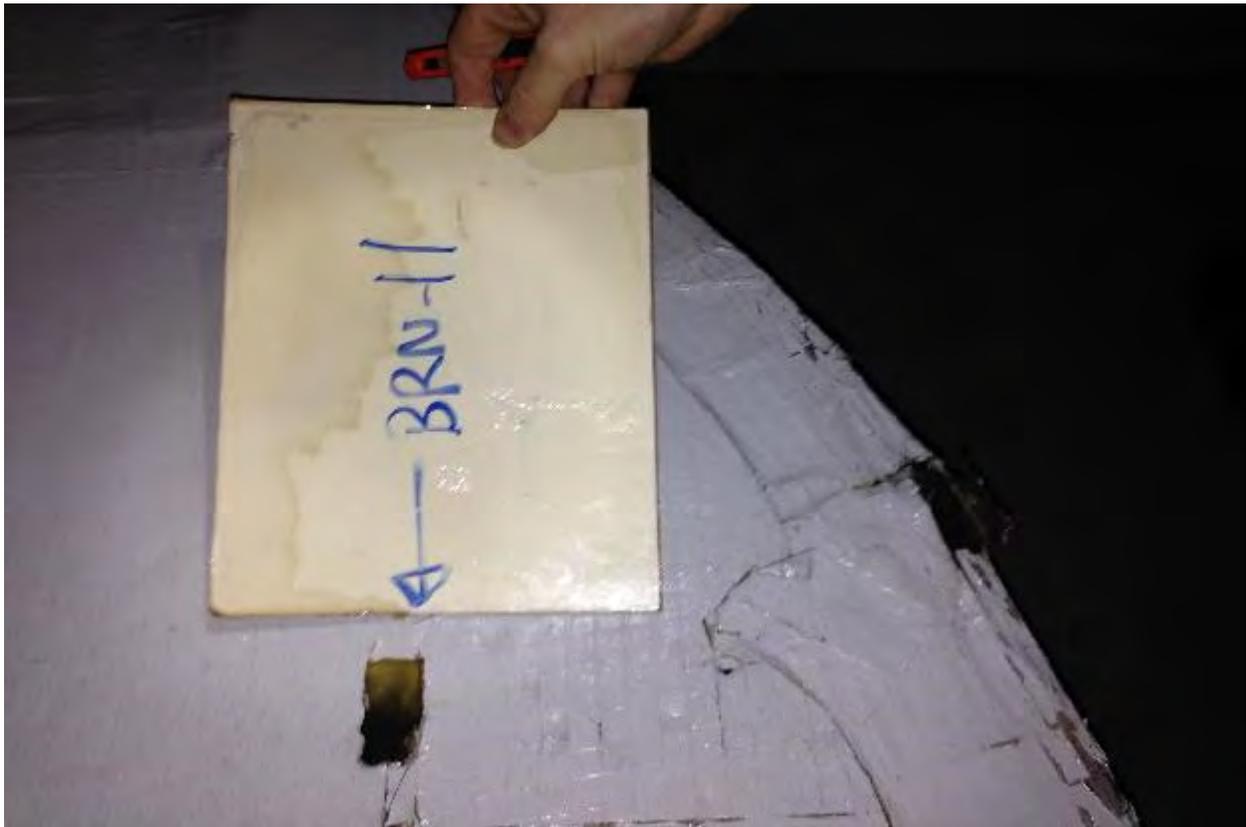
Plate 11: Laboratory analyses did not detect asbestos minerals within HVAC insulation sample BRN-11 collected from the North Administrative Building mechanical room.

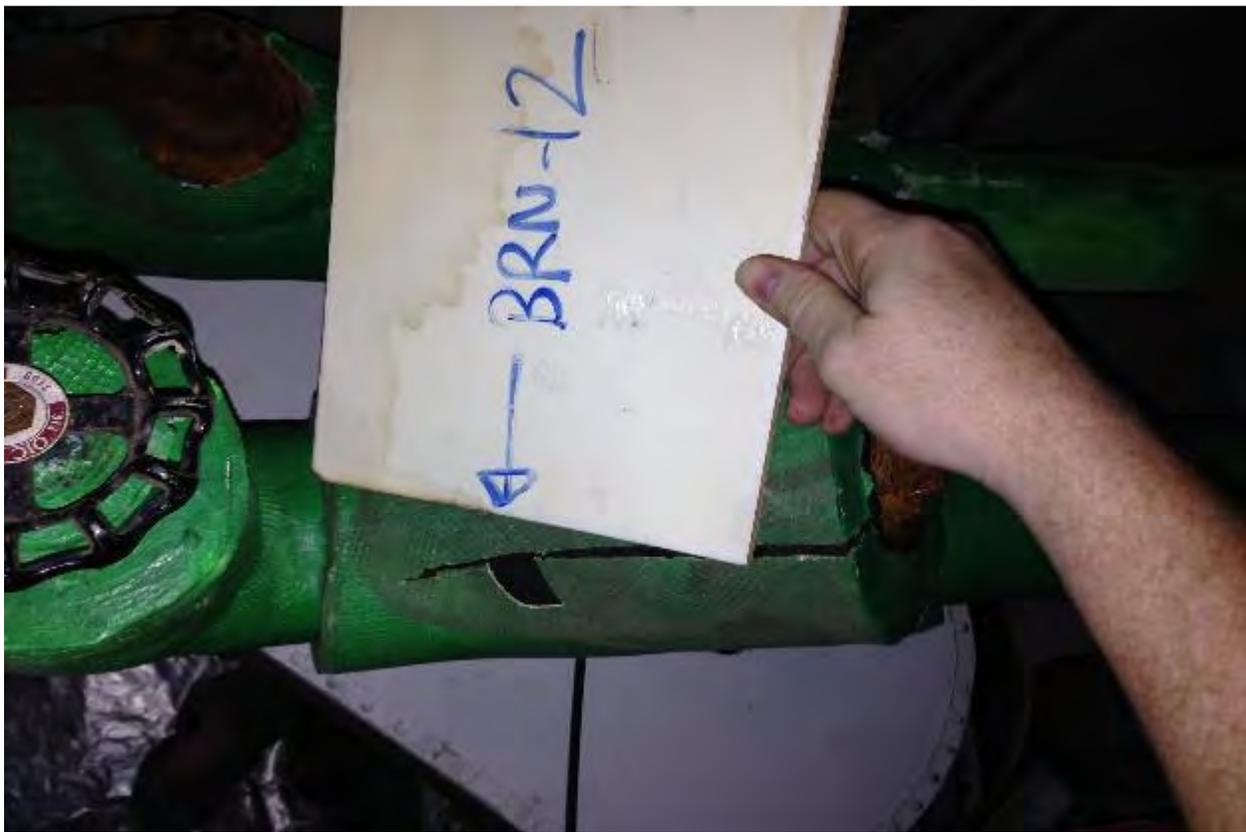
Plate 12: Laboratory analyses did not detect asbestos minerals within plumbing insulation sample BRN-12 collected from the North Administrative Building mechanical room.

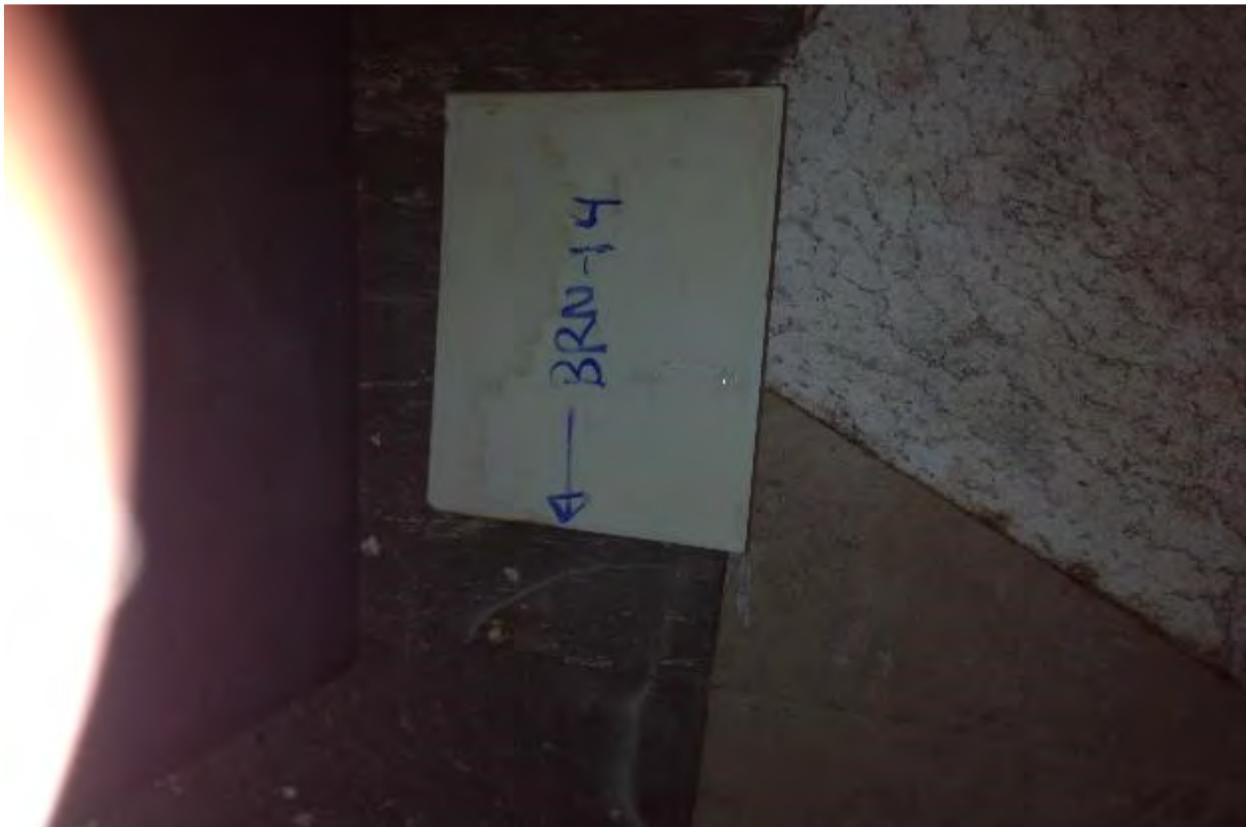
Plate 14: Laboratory analyses did not detect asbestos minerals within the floor tile or mastic sample BRN-14 collected from the North Administrative Building north rooms.

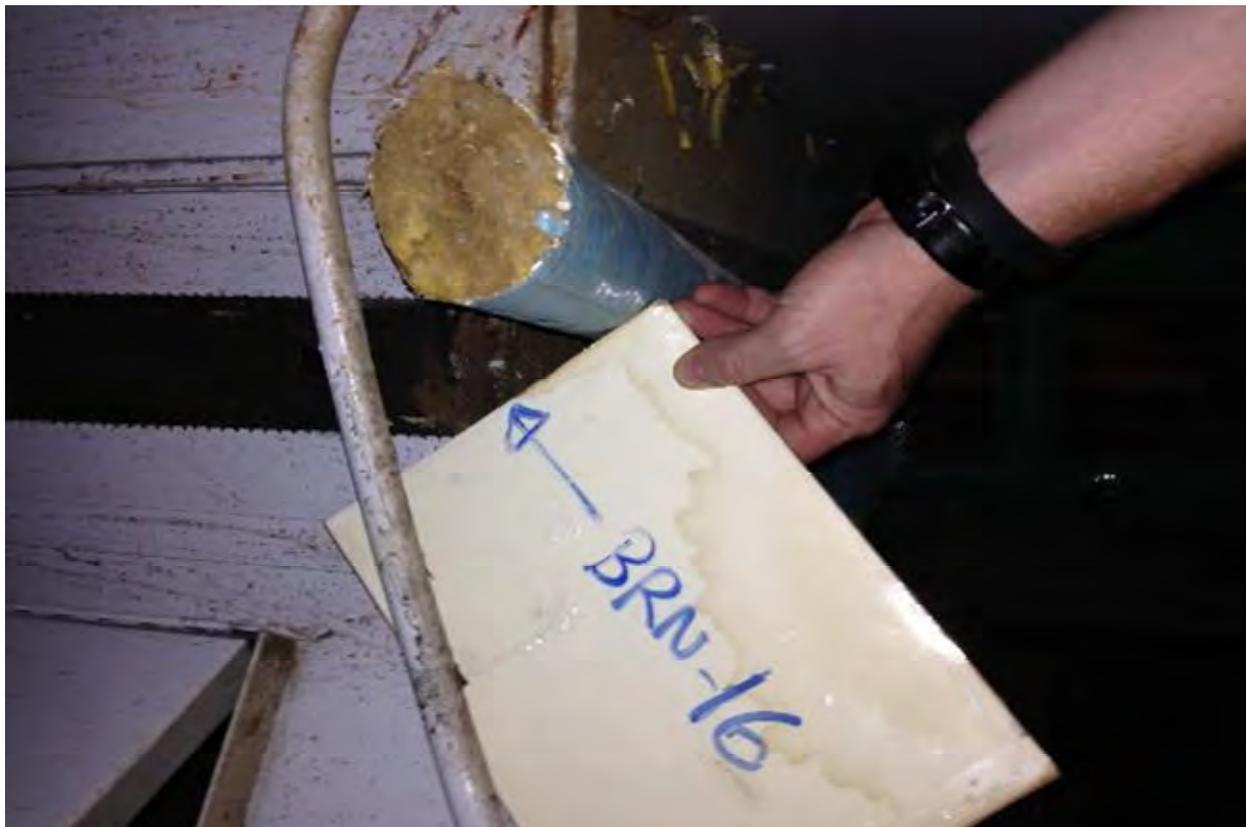
Plate 16: Laboratory analyses did not detect asbestos minerals within HVAC gasket sample BRN-16 collected from the North Administrative Building mechanical room.

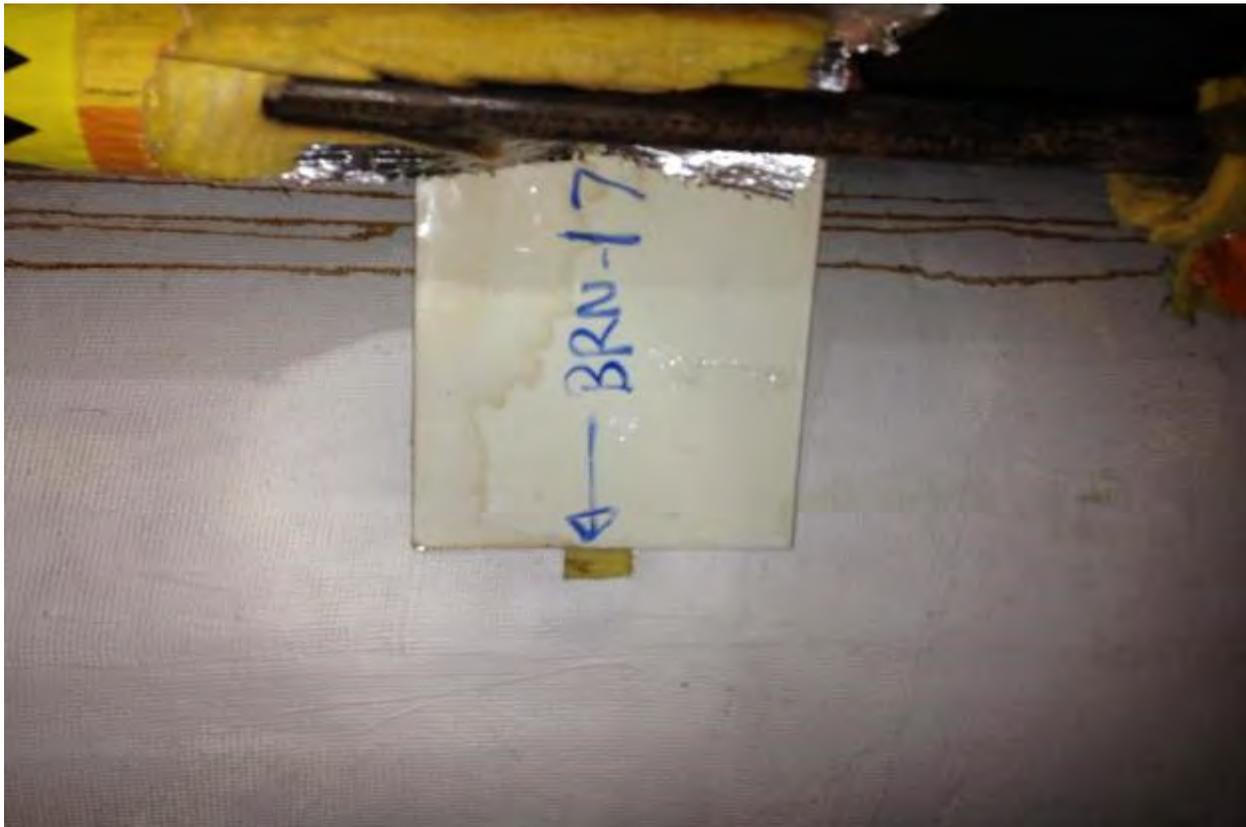
Plate 17: Laboratory analyses did not detect asbestos minerals within Boiler Wrap sample BRN-17 collected from the North Administrative Building mechanical room.

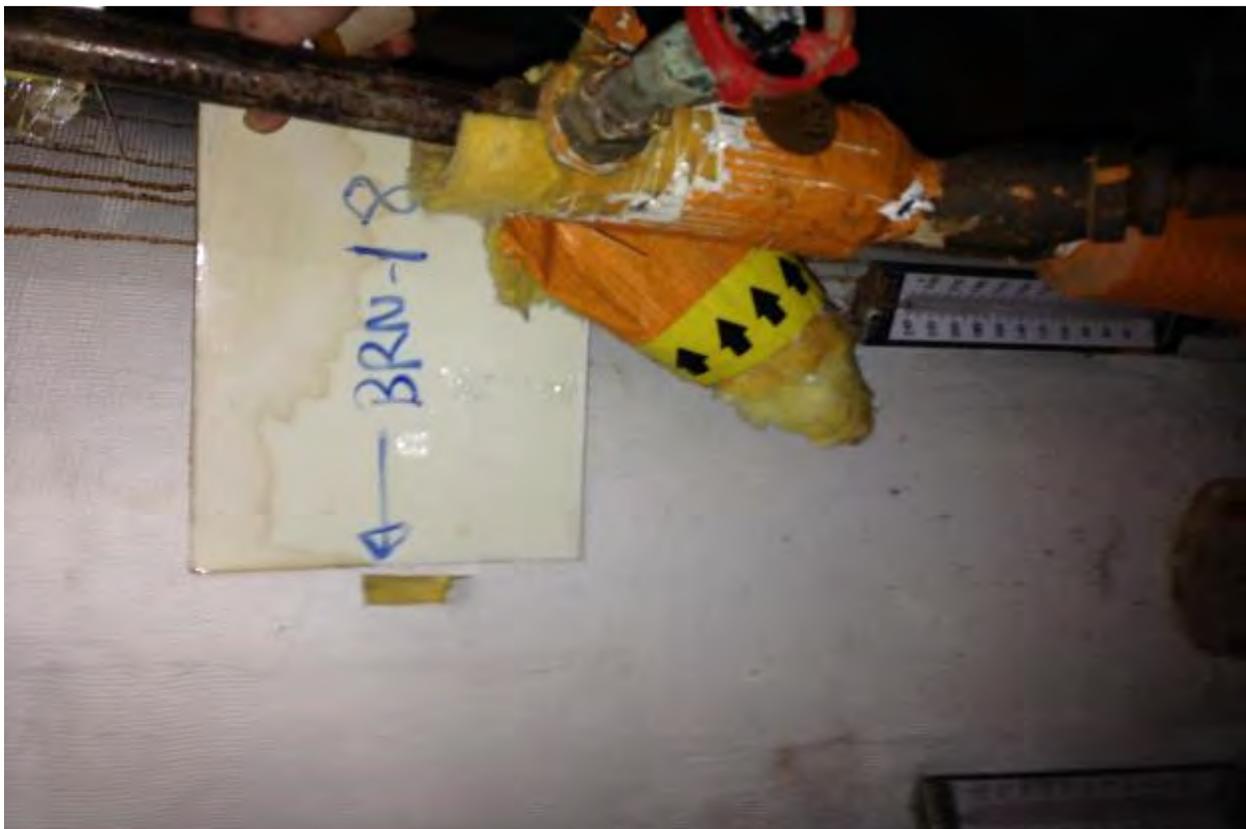
Plate 18: Laboratory analyses did not detect asbestos minerals within Boiler Wrap sample BRN-18 collected from the North Administrative Building mechanical room.

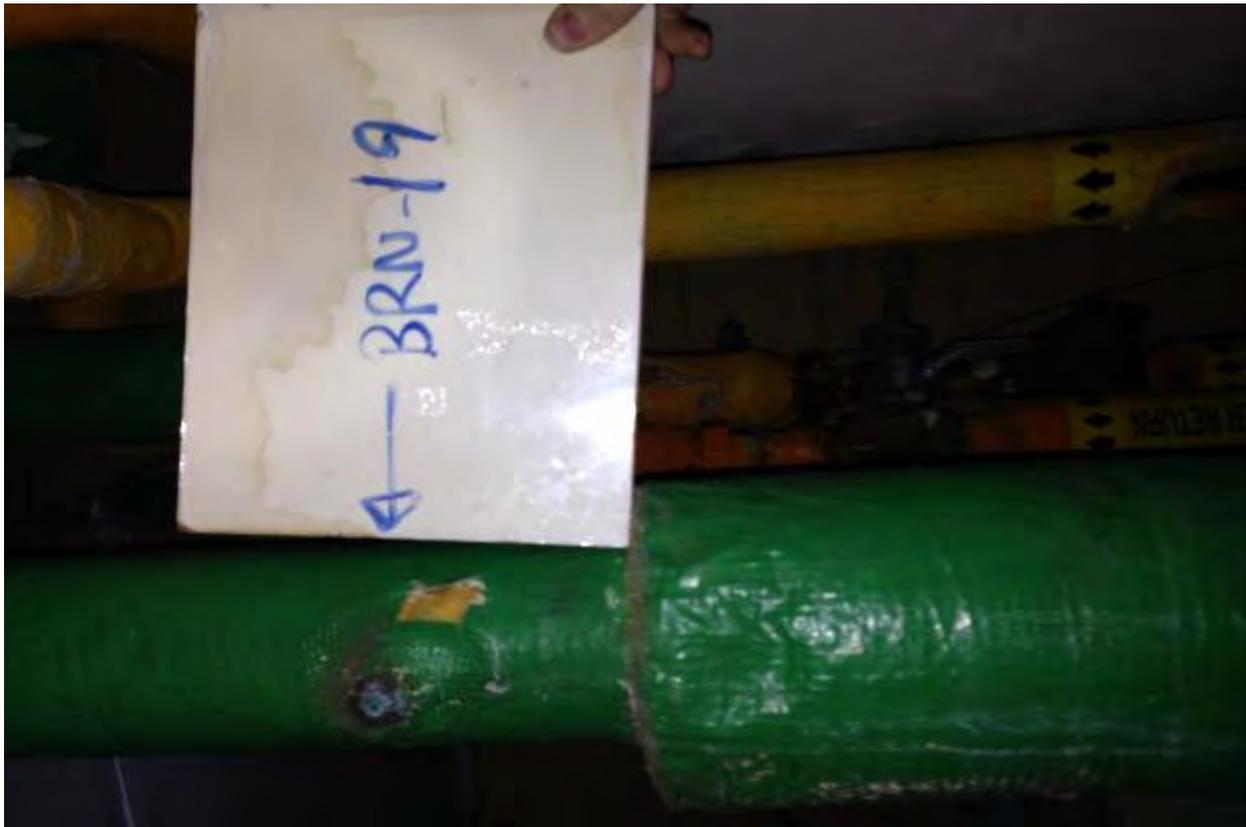
Plate 19: Laboratory analyses did not detect asbestos minerals within plumbing insulation sample BRN-19 collected from the North Administrative Building mechanical room.

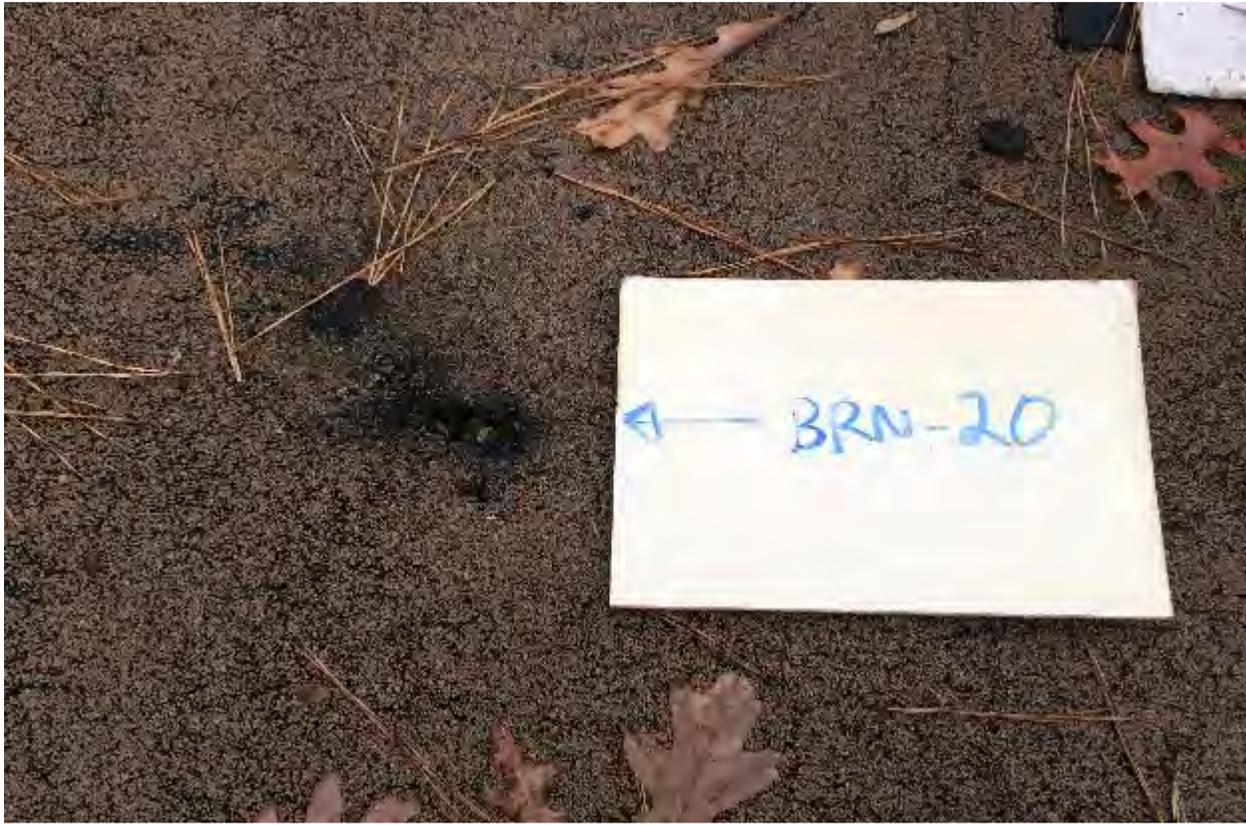
Plate 20: Laboratory analyses did not detect asbestos minerals within asphalt roof sample BRN-20 collected from the North Administrative Building roof.

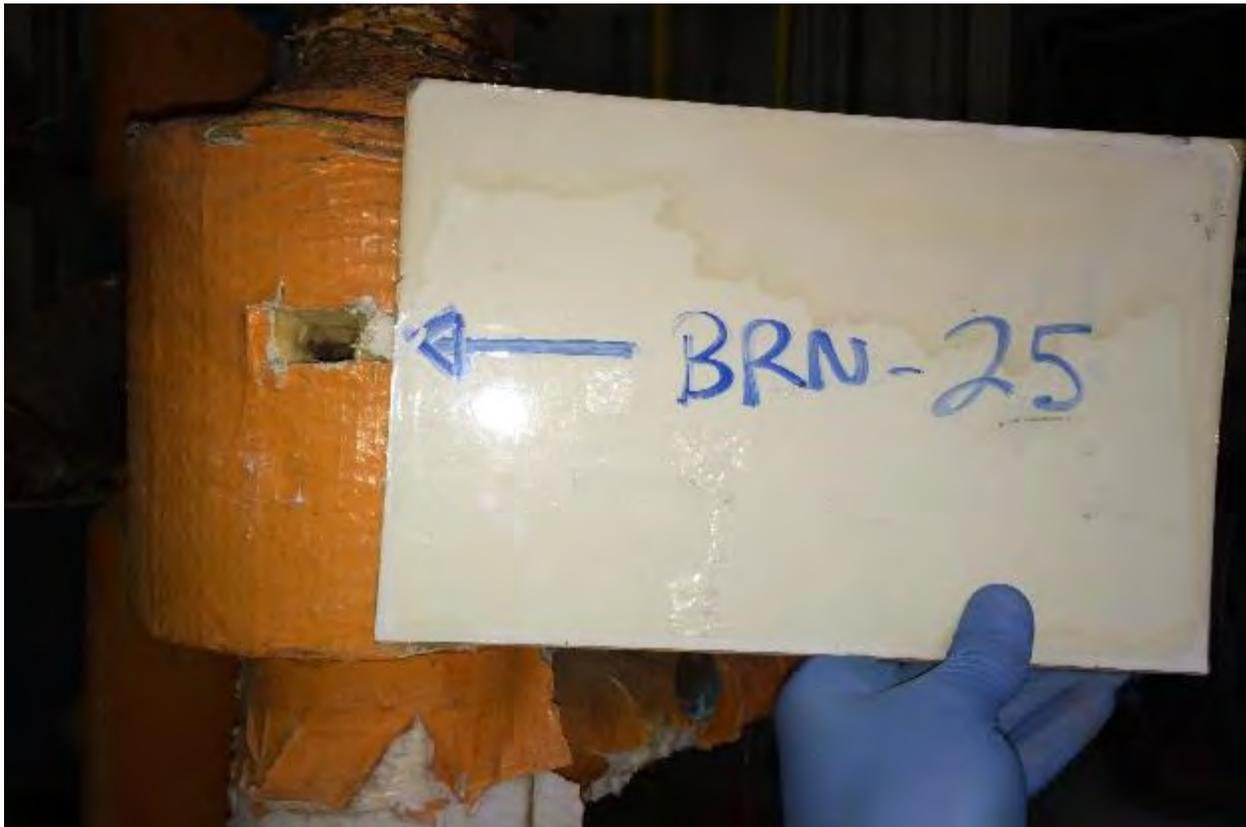
Plate 25: Laboratory analyses did not detect asbestos minerals within plumbing insulation sample BRN-25 collected from the South Administrative Building outdoor mechanical room.

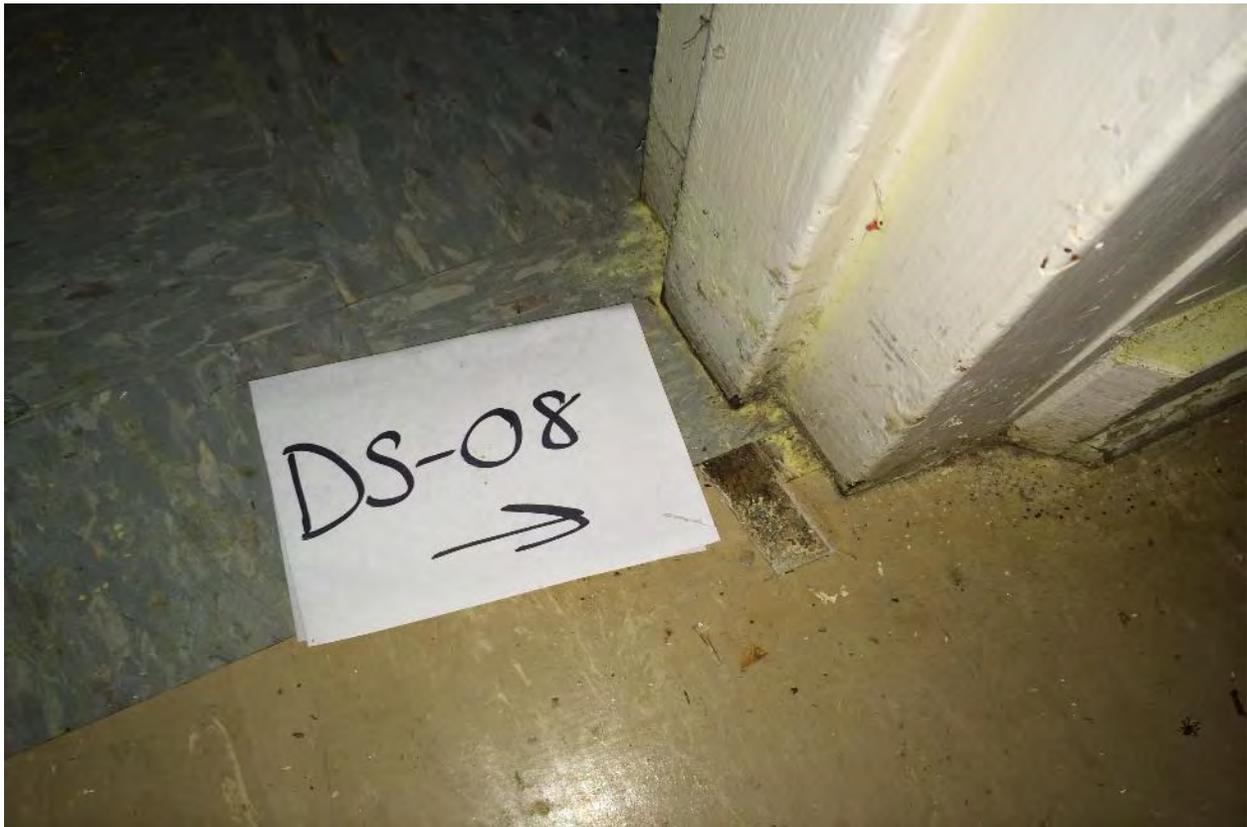
Plate 33: Laboratory analyses did not detect asbestos minerals within the beige floor tile or mastic sample DS-08 collected from the Dormitory Building upstairs hallway.

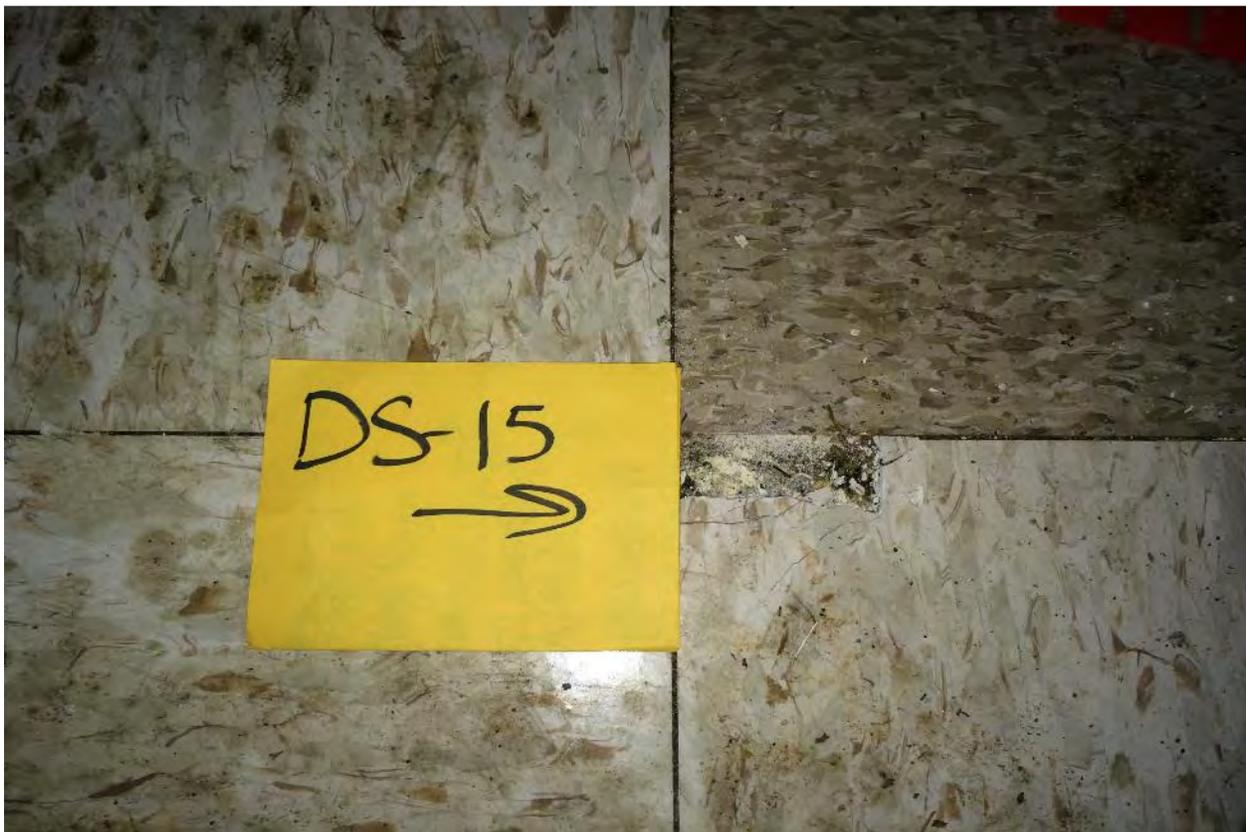
Plate 40: Laboratory analyses did not detect asbestos minerals within the tan and white floor tile or mastic sample DS-15 collected from the Dormitory Building downstairs hallways.

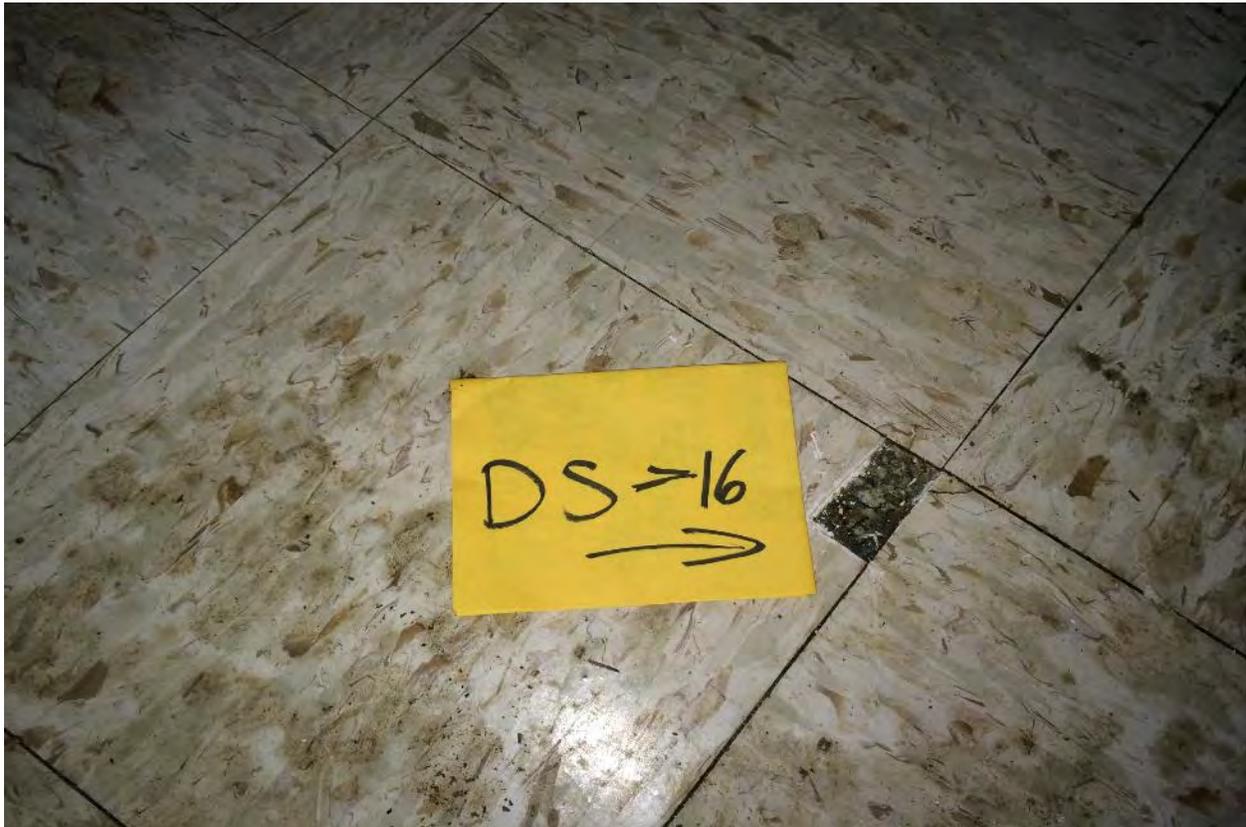
Plate 41: Laboratory analyses did not detect asbestos minerals within the tan and white floor tile or mastic sample DS-16 collected from the Dormitory Building downstairs hallways.

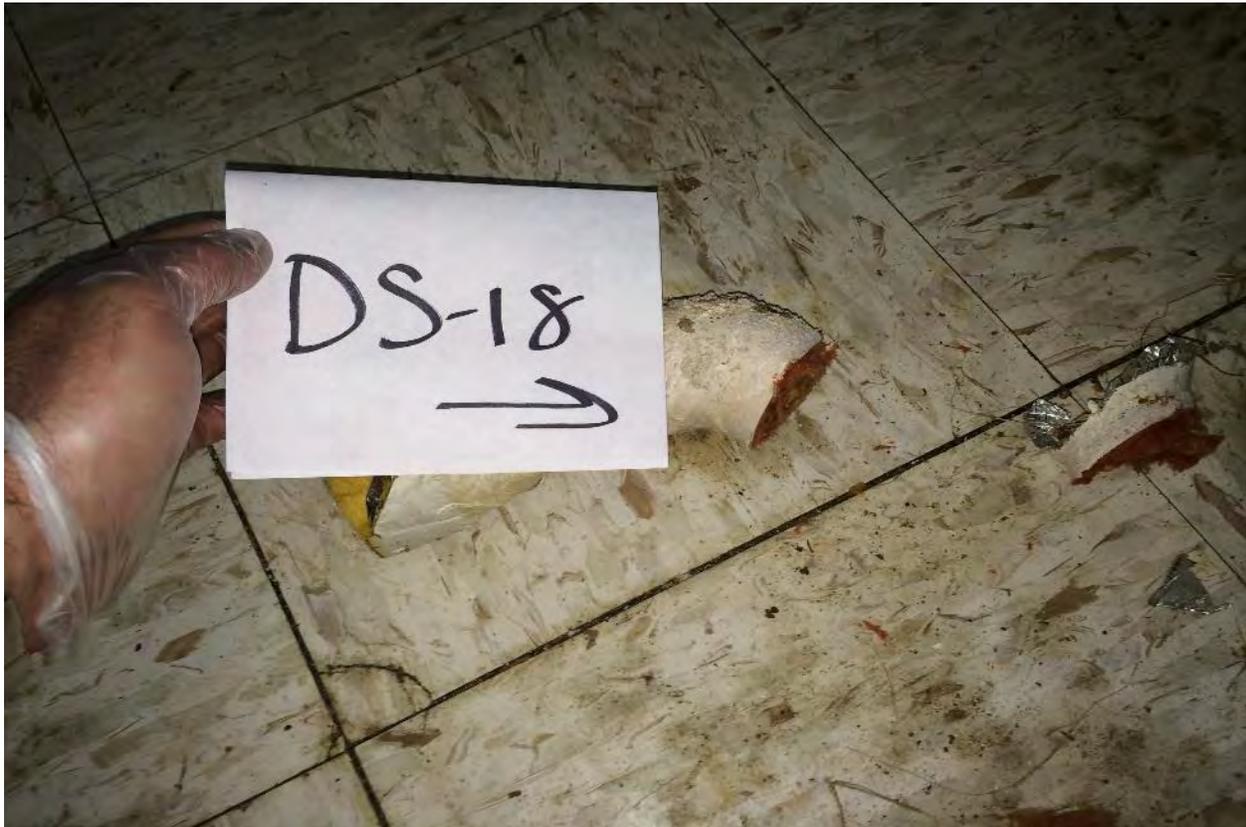
Plate 43: Laboratory analyses did not detect asbestos minerals within plumbing insulation sample DS-18 collected from the Dormitory Building downstairs training room.

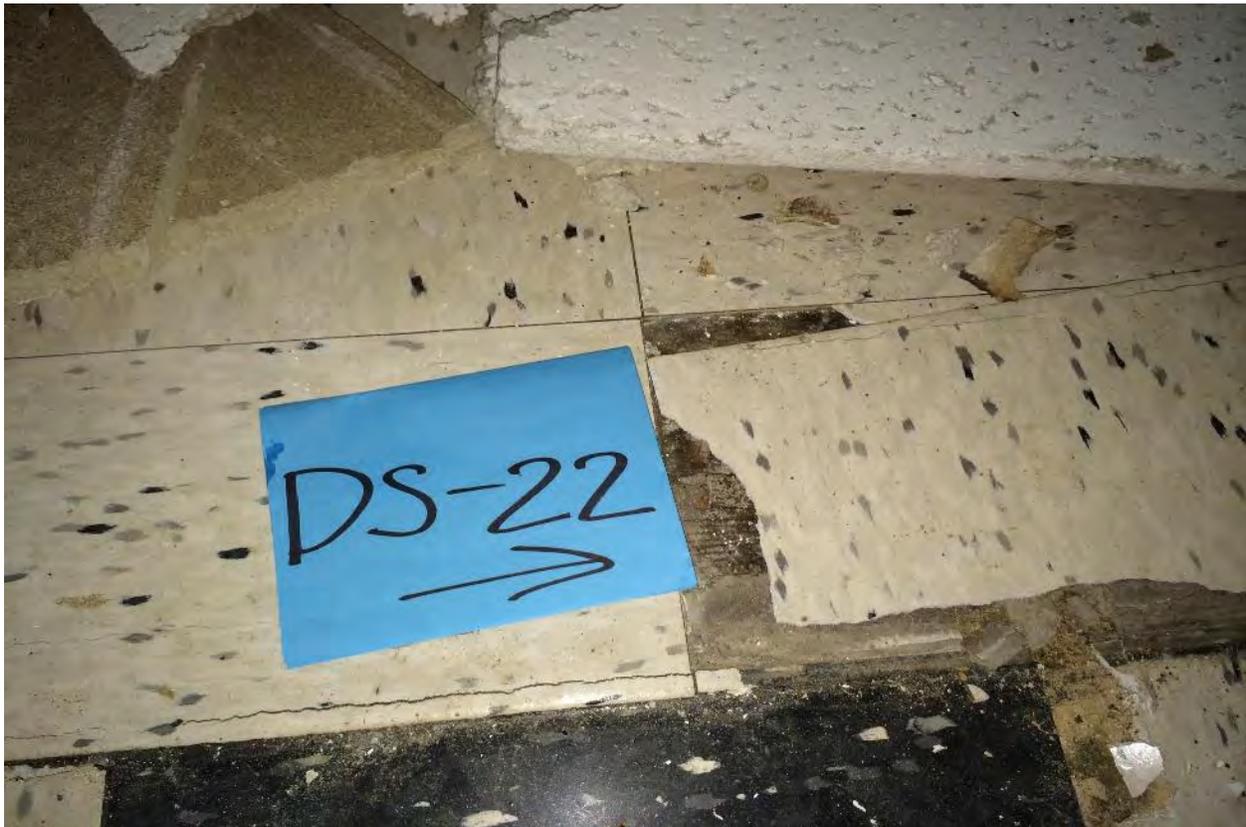
Plate 47: Laboratory analyses did not detect asbestos minerals within the black and white floor tile or mastic sample DS-22 collected from the Dormitory Building downstairs training room.

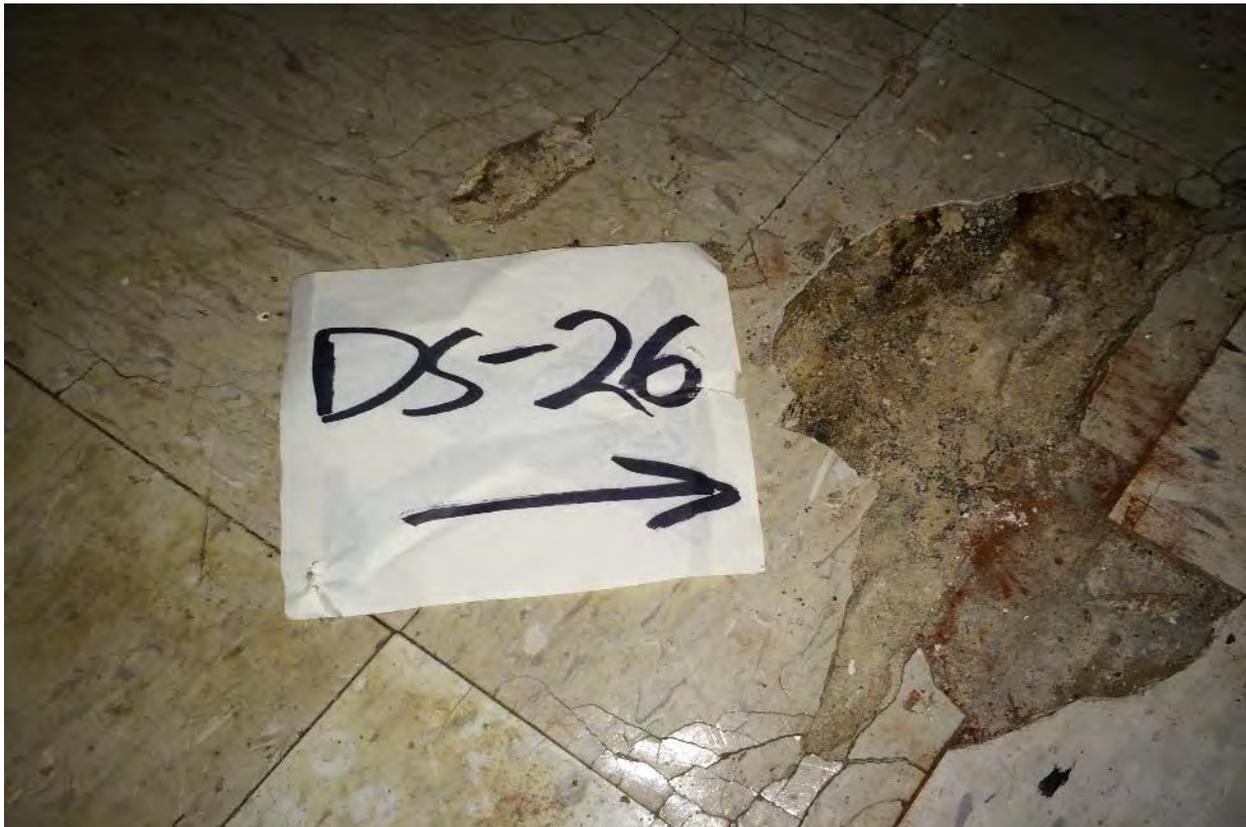
Plate 51: Laboratory analyses did not detect asbestos minerals within the black floor tile or mastic sample DS-26 collected from the Dormitory Building downstairs east miscellaneous rooms.

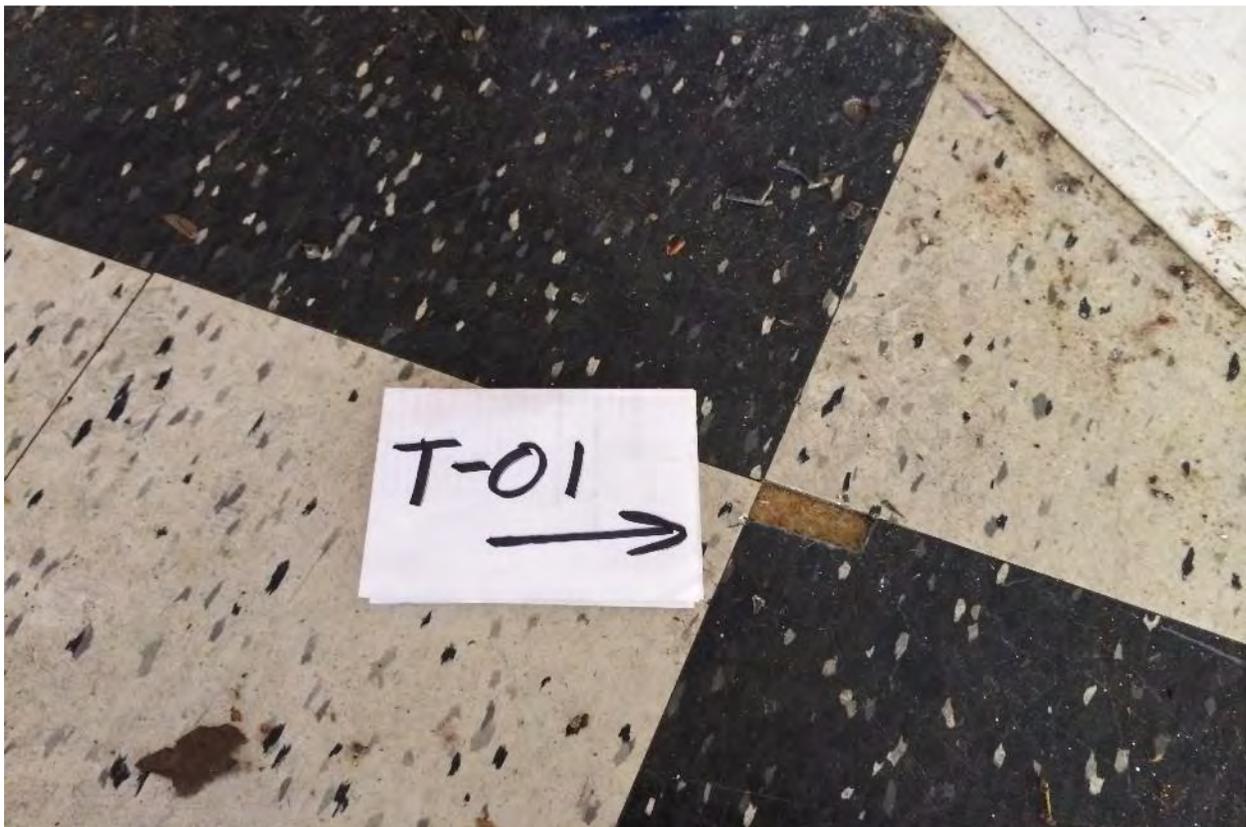
Plate 52: Laboratory analyses did not detect asbestos minerals within the black floor tile from sample TS-01 but did detect 5% chrysotile asbestos in the mastic from sample TS-01 collected from the Theatre Building lobby area.

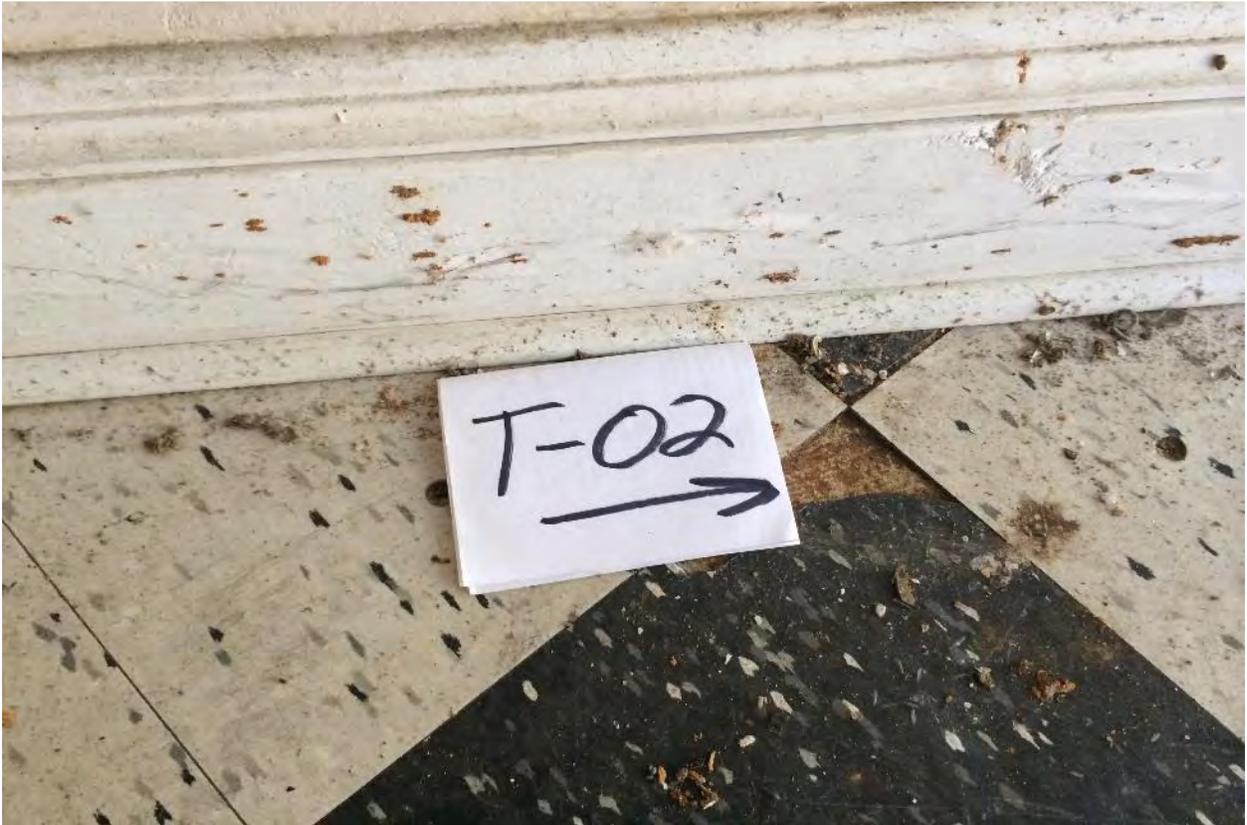
Plate 53: Laboratory analyses did not detect asbestos minerals within the black floor tile from sample TS-02 but did detect 5% chrysotile asbestos in the mastic from sample TS-02 collected from the Theatre Building lobby area.
