ITB 14-11

ITB 14-11 Demolition of Dormitory Building at Brook Run Park

The purpose of this Invitation to Bid (ITB) is to select a qualified contractor for the demolition and removal of two (2) structures from Brook Run Park. These structures are designated as the Dorm Building and the Pump Room on the provided site plan and environmental test correspondence. The

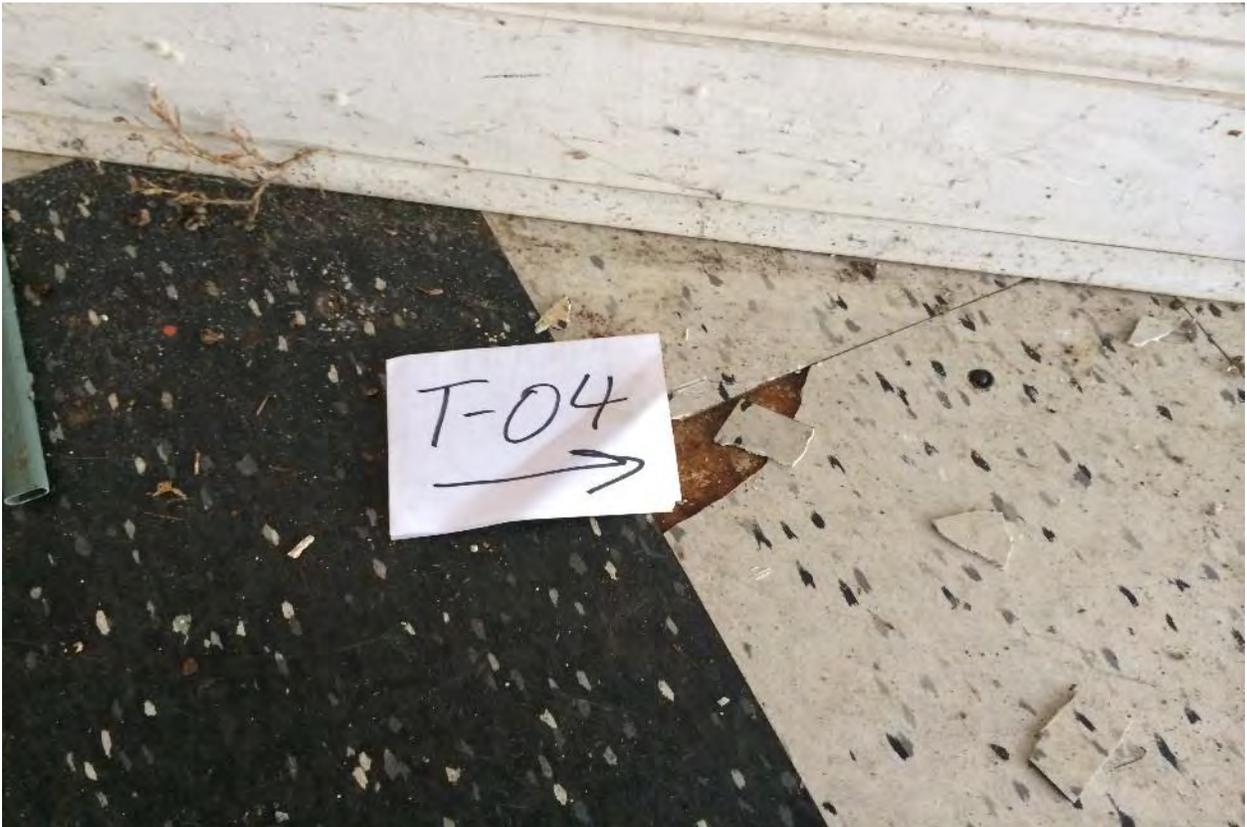
Plate 55: Laboratory analyses did not detect asbestos minerals within the white floor tile from sample TS-04 but did detect 5% chrysotile asbestos in the mastic from sample TS-04 collected from the Theatre Building lobby area.

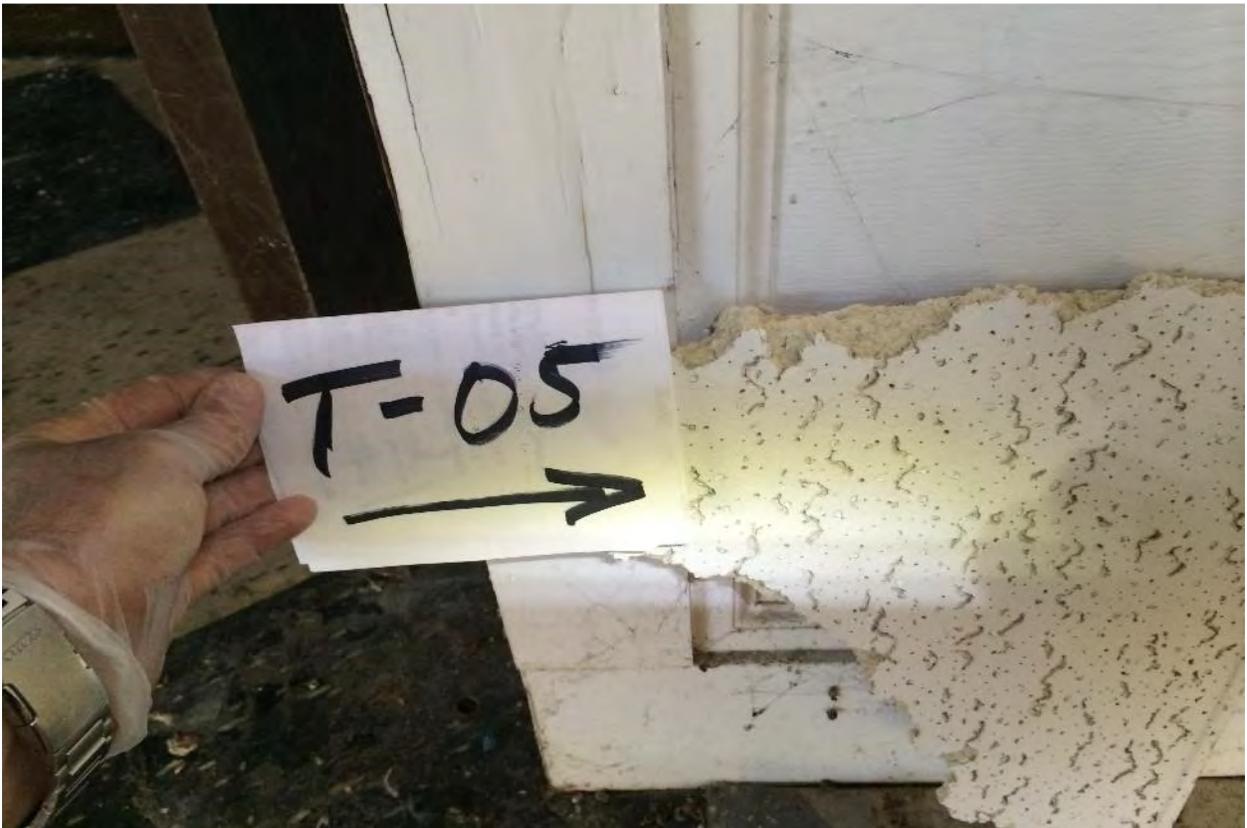
Plate 56: Laboratory analyses detected 2% chrysotile asbestos within suspended ceiling tile sample TS-05 collected from the Theatre Building lobby area.

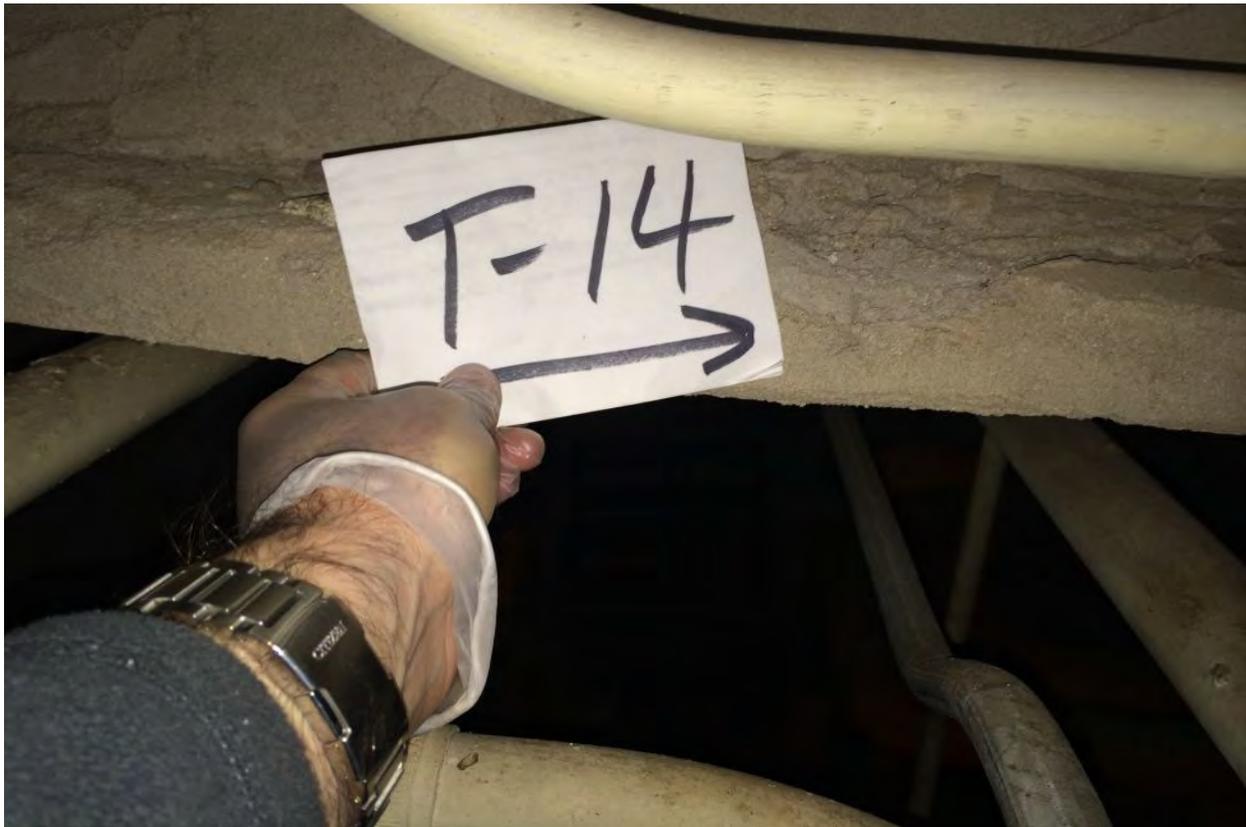
Plate 65: Laboratory analyses detected 20% chrysotile asbestos within spray on surfacing material sample TS-14 collected from the Theatre Building basement structural steel.

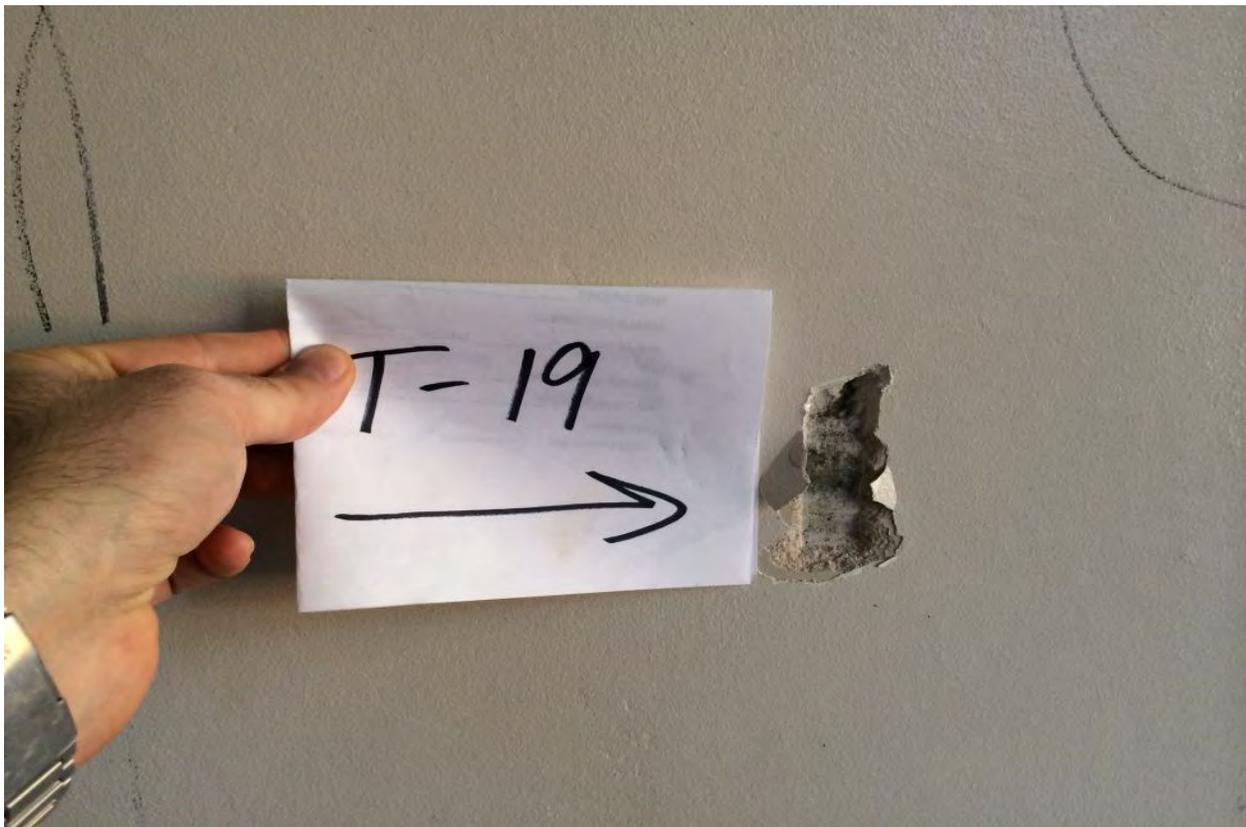
Plate 68: Laboratory analyses did not detect asbestos minerals within troweled on surfacing material sample TS-19 collected from the Theatre Building basement hall wall.

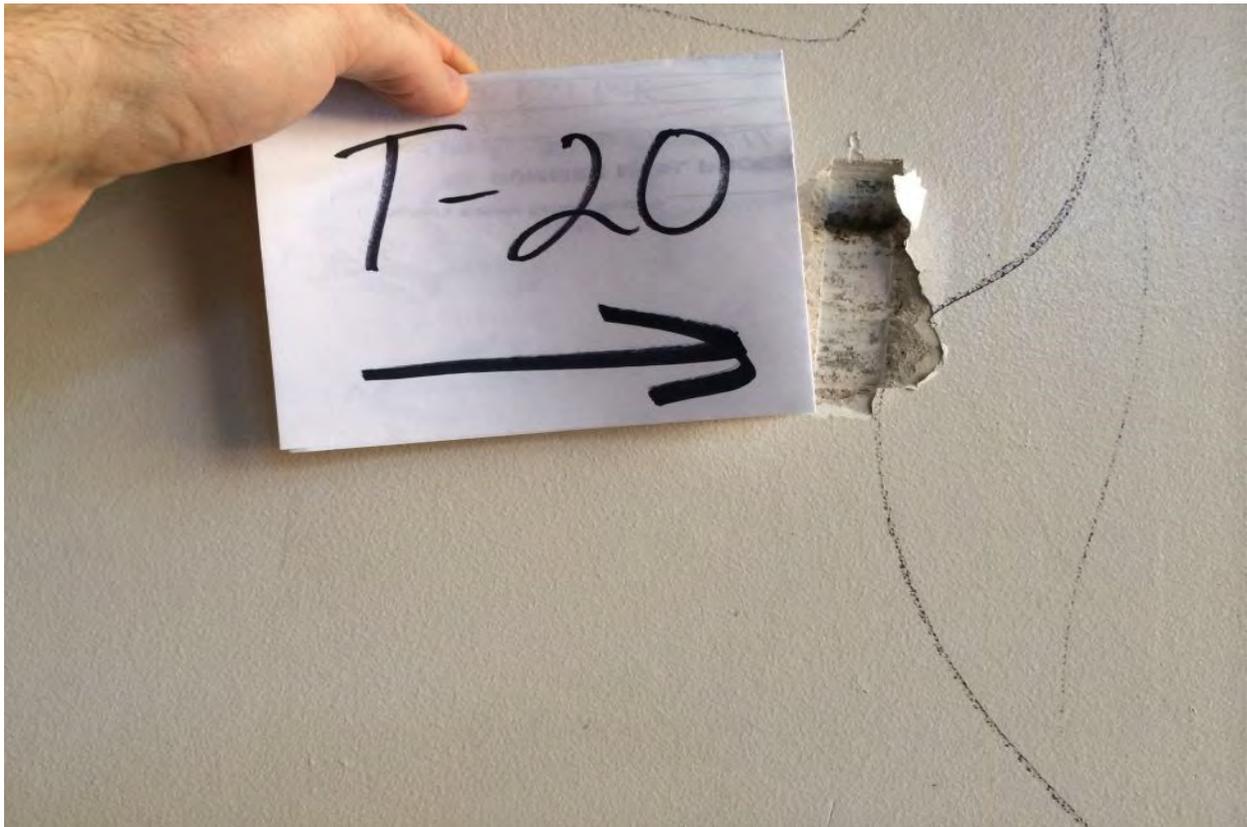
Plate 69: Laboratory analyses did not detect asbestos minerals within troweled on surfacing material sample TS-20 collected from the Theatre Building lobby wall.
