F I N A L R E P O R T

PEDESTRIAN SAFETY ACTION PLAN

Submitted to: **Dunwoody**
Smart people – Smart city

April 2014
Project # 019124006

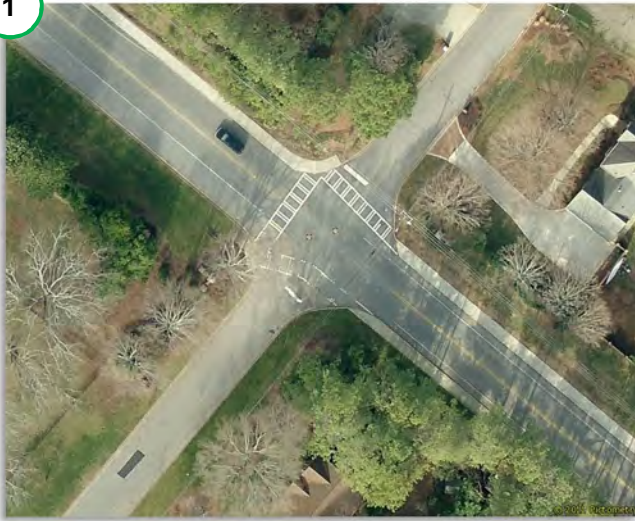
1

Chamblee Dunwoody Road at Redfield Road

The intersection at Chamblee Dunwoody Road and Redfield Road is located in the northwest quadrant of Dunwoody (#1: See Figure 2). There are existing sidewalks on the north side of Chamblee Dunwoody, east and west of the intersection, along with one on the south side of the roadway east of Redfield Road. The current crosswalk striping is worn. There are crosswalk signs on both sides of Chamblee Dunwoody Road and a “State Law: Stop for Pedestrians” in-street sign between the eastbound and westbound through lanes. There are motorist warning signs approximately 215 feet east and 260 feet west of the intersection. The existing treatment at the intersection is an overhead flashing beacon. During observations, two pedestrians mentioned that traffic does not usually stop at the crosswalk for pedestrians.

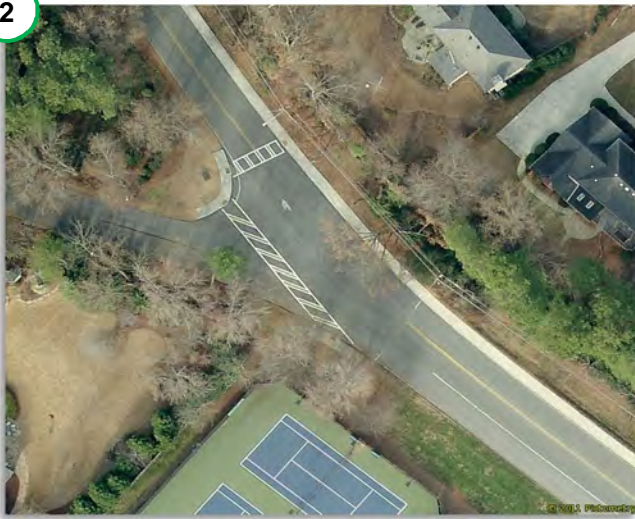
2

Chamblee Dunwoody Road at Dunwoody Road

The intersection at Chamblee Dunwoody Road and Dunwoody Road is located in the northwest quadrant of Dunwoody (#2: See Figure 2). There are existing sidewalks on the north side of Chamblee Dunwoody, east and west of the intersection and at the southwest corner. The current crosswalk striping is in good condition. Vegetation covers the only crosswalk sign that faces westbound travelers on Chamblee Dunwoody Road. There are motorist warning signs

approximately 240 feet east and 220 feet west of the intersection. The edge of road consists of curb and gutter along the north side of Chamblee Dunwoody Road and shoulder along the south side. The sight distance, when crossing southbound, is limited due to the horizontal alignment of the roadway and vegetation. There are no existing treatments to the crosswalks.

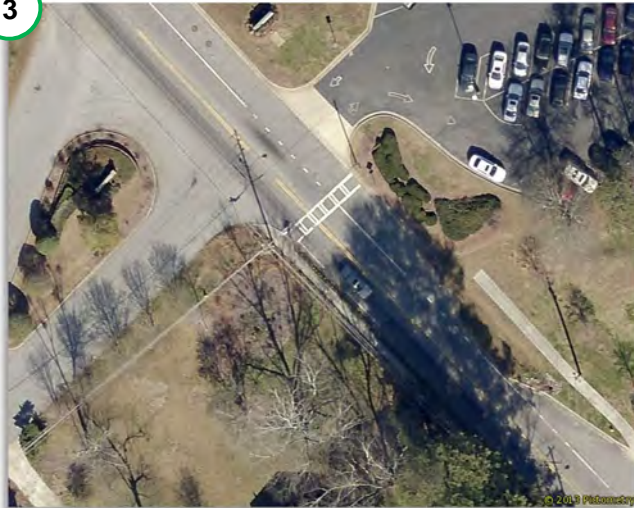
3

**Chamblee Dunwoody Road
at Kings Down Road**

The intersection at Chamblee Dunwoody Road at Kings Down Road is located in the southwest quadrant of Dunwoody (#3: See *Figure 2*). There are existing sidewalks south of the crosswalk on both the east and west sides of Chamblee Dunwoody Road. The current crosswalk striping is in good condition. Pedestrian crossing signage exists at the crosswalk. There are motorist warning signs approximately 340 feet north and 400 feet south of the intersection. The edge of road consists of curb and gutter along both sides of Chamblee Dunwoody Road. There are no existing treatments to the crosswalks.

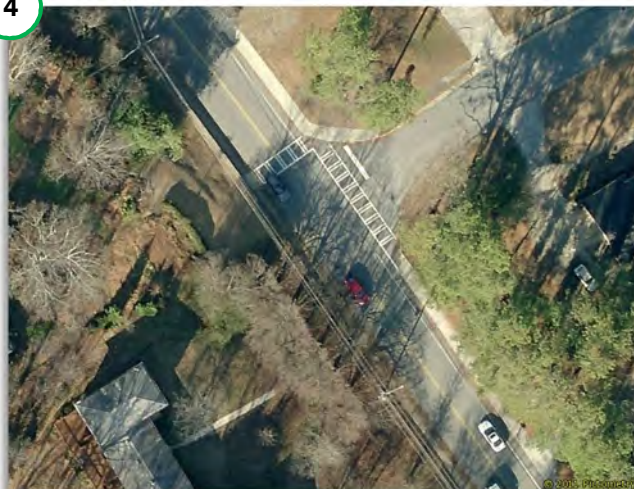
**Chamblee Dunwoody Road
at Dunwoody Knoll Drive**

Chamblee Dunwoody; however, the width of the sidewalk on the west side of the road is only 4 feet. The current crosswalk striping is in good condition. Vegetation covers the pedestrian crossing sign facing westbound travelers on Chamblee Dunwoody Road. There are motorist warning signs approximately 390 feet north and 370 feet south of the intersection. The edge of road consists of curb and gutter along the north side of Chamblee Dunwoody Road and shoulder along the south side. The sight distance when crossing northbound is limited due to vegetation. While there are no existing treatments to the crosswalks, there are overhanging speed limit beacons to the north and south of the crosswalks for school hours.

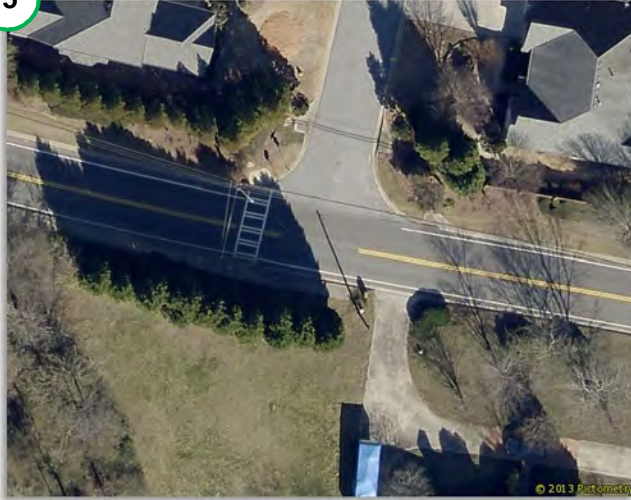
5

Dunwoody Club Drive at Dunwoody Club Creek

The intersection at Dunwoody Club Drive and Dunwoody Club Creek is located in the northeast quadrant of Dunwoody (#5: See Figure 2). There are existing sidewalks on the south side of Dunwoody Club Drive, east and west of the intersection. The current crosswalk striping is in good condition. There are motorist warning signs approximately 480 feet east and 400 feet west of the intersection, but pedestrian crossing signs at the crosswalk do not exist. The edge of road consists of a shoulder and curb. The sight distance when crossing southbound, facing west, is limited due to the horizontal alignment of the roadway and vegetation. There are no existing treatments to the crosswalks. While the crosswalk is ADA-compliant, the north side ramp is not flush with the crosswalk.

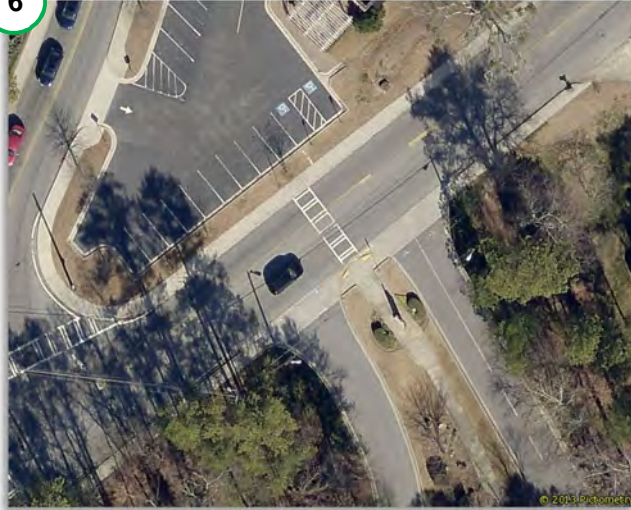
6

Mt. Vernon Road at All Saints Catholic Church Driveway

The intersection at Mt. Vernon Road and the All Saints Catholic Church driveway is located in the northeast quadrant of Dunwoody (#6: See *Figure 2*). There are existing sidewalks on both sides of Mt. Vernon Road, east and west of the intersection. The current crosswalk striping is in fair condition. There are pedestrian crossing signs on both sides of the roadway; however, the east-facing sign is currently covered by vegetation. Motorist warning signs exist approximately 100 feet east and 92 feet west of the intersection. The edge of road consists of curb and gutter. There are no existing treatments to the crosswalks. There is concern that the unsignalized crosswalk is too close to a signalized intersection and could be unsafe for pedestrians during times of heavy traffic and queuing. Also, the west-facing motorist warning sign does not meet the Manual on Uniform Traffic Control Devices (MUTCD) guidelines, which state that an advanced warning sign should be placed 100 feet from the crosswalk in a 35 mph zone.

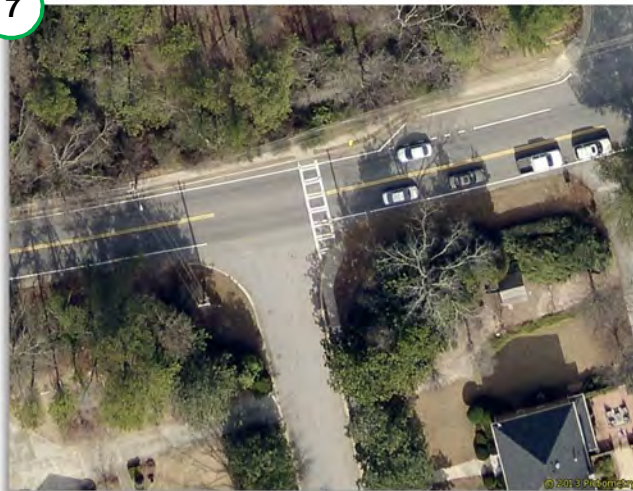
7

Mt. Vernon Road at Stratham Drive

The intersection at Mt. Vernon Road and Stratham Drive is located in the northeast quadrant of Dunwoody (#7: See *Figure 2*). There is existing sidewalk on the north side of Mt. Vernon Road, east and west of the intersection. The current crosswalk striping is in good condition. Pedestrian crossing signs are posted at the crosswalk. There are motorist warning signs approximately 300 feet east and 480 feet west of the intersection. The edge of road consists of curb and gutter along

the north side of Chamblee Dunwoody Road and shoulder along the south side. The sight distance when crossing southbound is limited due to the horizontal alignment of the roadway and vegetation. There is an existing in-road sign located at the crosswalk.

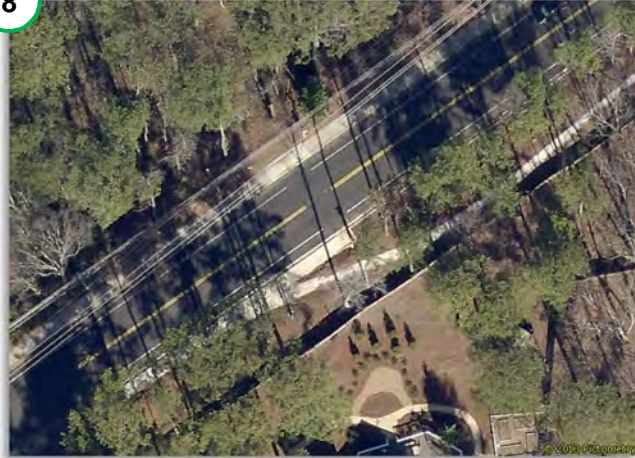
8

Mt. Vernon Road between Ridgeview Road and Trailbridge Drive

- Nearby School:** None
- Land Use:** Residential
- Posted Speed:** 35 mph
- Number of Lanes:**
 - Mt. Vernon Road – 2
- Vehicular ADT:** 21,909 vehicles/day
- Peak Hour AM (PM) Pedestrian Volumes:** 7 (2)
- ADA Compliance:** Yes (with domes)
- Sight Distance:** Sufficient
- Lighting:** Insufficient

The crosswalk on Mt. Vernon Road between Hidden Branch Drive and Trailbridge Drive is located in the northwest quadrant of Dunwoody (#8: See Figure 2). There are existing sidewalks on both sides of Mt. Vernon Road, east and west of the intersection. The current crosswalk striping is in good condition. Pedestrian crossing signs are located on both sides of the crosswalk. Motorist warning signs “State Law: Stop for Pedestrians” are located at Ridgeview Road and east of the crosswalk. The edge of road consists of curb and gutter along both sides of Mt. Vernon Road. Sight distance at the crosswalk is good. Flashing beacons are on the two pedestrian signs at the crosswalk, including pedestrian push buttons.

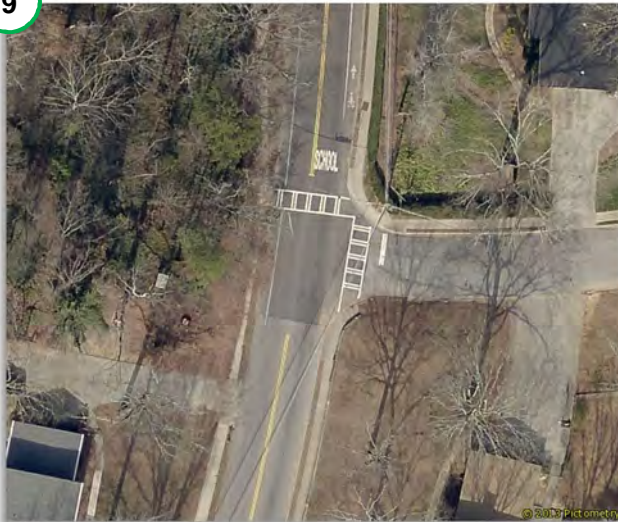
9

N Peachtree Road at Brookhurst Drive

- Nearby School:** Chesnut Elementary School
- Land Use:** Residential
- Posted Speed:** 35 mph (25 mph School Zone)
- Number of Lanes:**
 - N Peachtree Road – 2
 - Brookhurst Drive – 2
- Vehicular ADT:** 15,378 vehicles/day
- Peak Hour AM (PM) Pedestrian Volumes:** 8 (7)
- ADA Compliance:** Yes (no domes)
- Sight Distance:** Sufficient
- Lighting:** Insufficient

The intersection at N Peachtree Road and Brookhurst Drive is located in the southeast quadrant of Dunwoody (#9: See Figure 2). There are existing sidewalks on both sides of N Peachtree Road. The current crosswalk striping is in good condition. Advanced motorist warning signs and pedestrian

crossing signs are not located at the crosswalk. The edge of road consists of curb and gutter. The sight distance for pedestrians is sufficient; however, the sight distance for motorists on Brookhurst Drive is limited behind the stop bar. There are no existing treatments to the crosswalks, although there is an overhead flashing beacon for the School Zone speed limit change. A MARTA bus stop is located at the crosswalk.

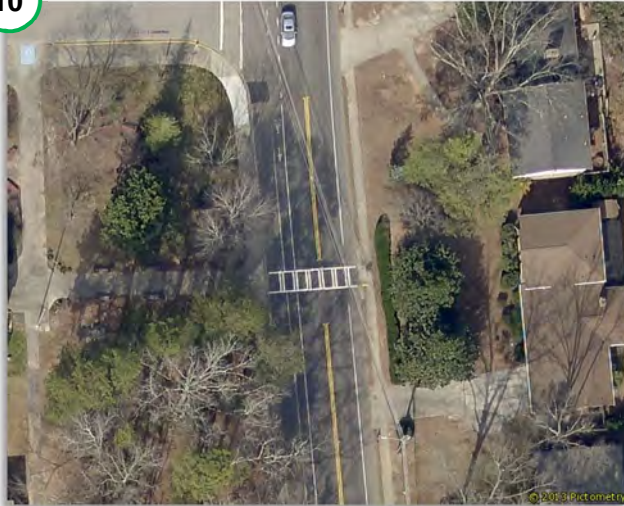
10

N Peachtree Road between Peachford Road and Brookhurst Drive

The crossing on N Peachtree Road between Peachford Road and Brookhurst Drive is located in the southeast quadrant of Dunwoody (#10: See *Figure 2*). There are existing sidewalks on both sides of N Peachtree Road. The sidewalks have no buffer on the west side and a 2 foot buffer on the east side of the road. The current crosswalk striping is in good condition. Pedestrian signage is located at the crosswalk, facing south and approximately 60 feet from the crosswalk facing north. There also is an in-street pedestrian crossing sign and during school arrival and dismissal there is a school crossing guard. There is one motorist warning sign approximately 270 feet to the south of the crosswalk. The edge of road consists of curb and gutter. When facing north, the sight distance for pedestrians crossing eastbound is limited. There is an existing in-road sign at the crosswalk.

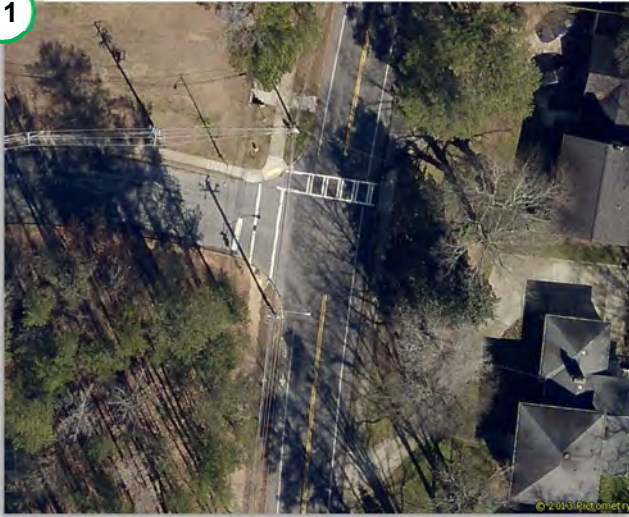
11

**N Peachtree Road at
Peachford Road**

The intersection at N Peachtree Road and Peachford Road is located in the southeast quadrant of Dunwoody (#11: See *Figure 2*). There are existing sidewalks on both sides of N Peachtree Road. The sidewalk on the east side has a 2-foot buffer. The sidewalk on the west side has a 10-foot buffer. The current crosswalk striping is in good condition. Pedestrian signage is located at the crosswalk facing north and south. A motorist warning sign is approximately 240 feet north of the intersection, but there is not a south facing advance warning sign. The edge of road consists of curb and gutter. There are no existing treatments to the crosswalks. A MARTA bus stop is located at the crosswalk. Stopped buses may limit sight while loading and unloading.

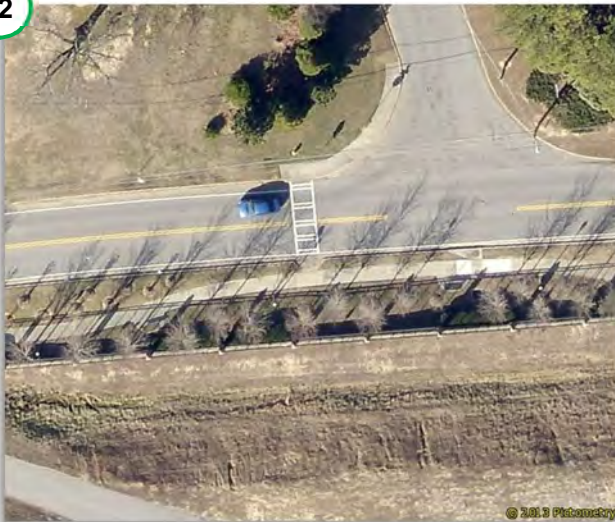
12

**Peeler Road at
Lakeside Drive**

The intersection at Peeler Road and Lakeside Drive is located in the southeast quadrant of Dunwoody (#12: See *Figure 2*). There is an existing sidewalk on the south side of Peeler Road along the reservoir property. The current crosswalk striping is in good condition. Pedestrian signage is located at the crosswalk facing both directions of traffic. There are no advanced motorist warning signs for the crosswalk. The edge of road consists of curb and gutter with a 2-foot buffer. The sight

distance when crossing northbound is limited due to vegetation. There are no existing treatments to the crosswalks.

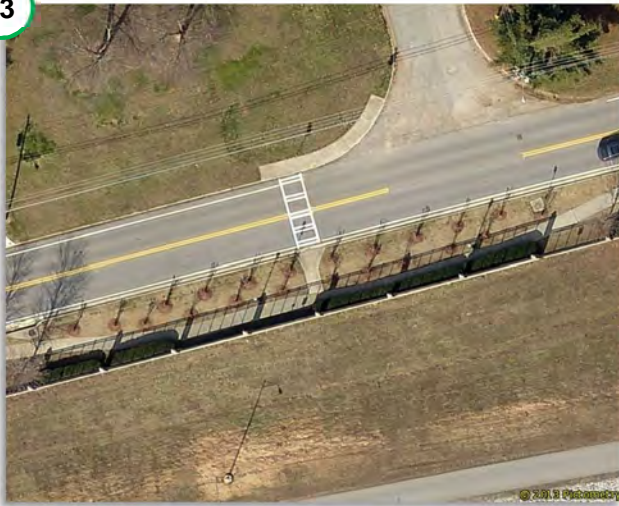
13

Peeler Road at Windwood Drive

- Nearby School:** None
- Land Use:** Residential/Recreational
- Posted Speed:** 35 mph
- Number of Lanes:**
 - Peeler Road – 2
 - Windwood Drive – 2
- Vehicular ADT:** 7,670 vehicles/day
- Peak Hour AM (PM) Pedestrian Volumes:** 0 (0)
- ADA Compliance:** Yes (no domes)
- Sight Distance:** Sufficient
- Lighting:** Sufficient

The intersection at Peeler Road and Windwood Drive is located in the southeast quadrant of Dunwoody (#13: See Figure 2). There is existing sidewalk on the south side of Peeler Road along the reservoir property. The current crosswalk striping is in good condition. Pedestrian signage is present on both sides of the crosswalk. There are advanced motorist warning signs approximately 330 feet east and 440 feet west of the intersection. The edge of road consists of curb and gutter along the south side of Peeler Road and shoulder along the north side. There are no existing treatments to the crosswalks.

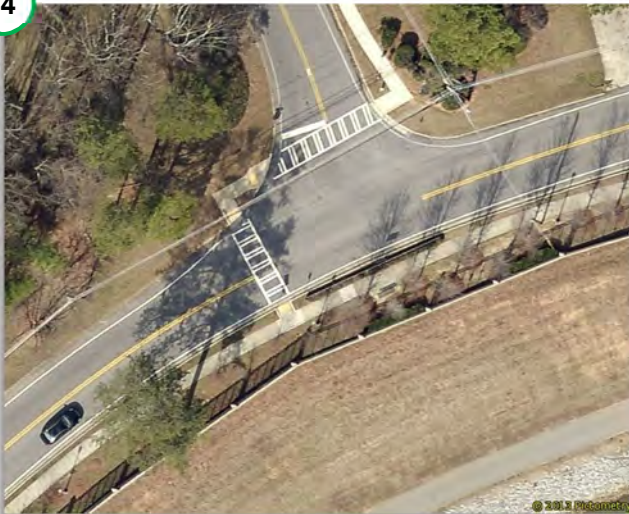
14

Peeler Road at Happy Hollow Road

- Nearby School:** None
- Land Use:** Residential/Recreational
- Posted Speed:** 35 mph
- Number of Lanes:**
 - Peeler Road – 2
 - Happy Hollow Road – 2
- Vehicular ADT:** 6,270 vehicles/day
- Peak Hour AM (PM) Pedestrian Volumes:** 1 (1)
- ADA Compliance:** Yes (no domes)
- Sight Distance:** Limited
- Lighting:** Sufficient

The intersection at Peeler Road and Happy Hollow Road is located in the southeast quadrant of Dunwoody (#14: See Figure 2). There is existing sidewalk on the south side of Peeler Road and along the east side of Happy Hollow Road. The current crosswalk striping is in good condition. Pedestrian signage is located on both sides of the crosswalk. There are advanced motorist warning signs approximately 340 feet east and 250 feet west of the crosswalk. The edge of road consists of

curb and gutter along both sides of Peeler Road with a 2-foot buffer. The sight distance when crossing northbound is limited due to the horizontal alignment of the roadway and vegetation. There are no existing treatments to the crosswalks.

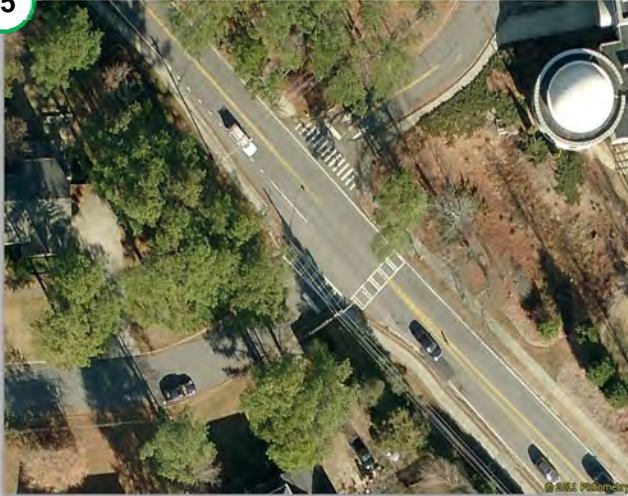
15

**Tilly Mill Road at
Dunwoody Glen**

The intersection at Tilly Mill Road and Dunwoody Glen is located in the northeast quadrant of Dunwoody (#15: See *Figure 2*). There are existing sidewalks on both sides of Tilly Mill Road. The current east and west crosswalk striping is in good condition. The south crosswalk is currently worn. Vegetation covers the pedestrian sign that faces southbound traffic on Tilly Mill Road. There are no advanced motorist warning signs for the crosswalks. The edge of road consists of curb and gutter with a 2-foot buffer. There are no existing treatments to the crosswalk.

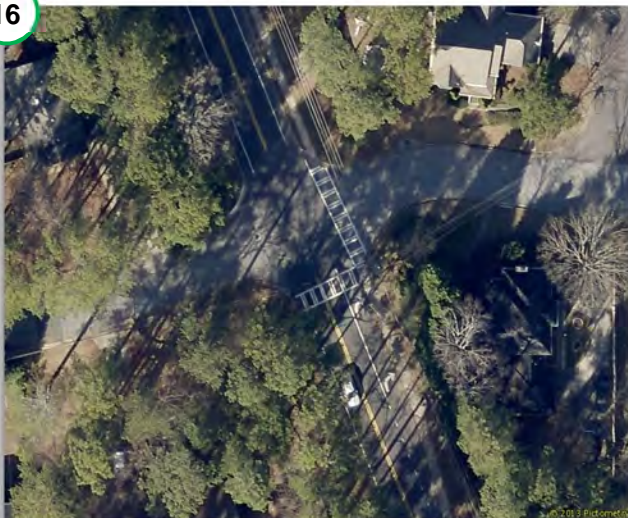
16

**Tilly Mill Road at
Andover Drive**

The intersection at Tilly Mill Road and Andover Drive is located in the southeast quadrant of Dunwoody (#16: See *Figure 2*). There is an existing 4-foot wide sidewalk on the east side of Tilly Mill Road. There is a sidewalk buffer to the north of the intersection, but not to the south. The current east crosswalk striping is in good condition while the south crosswalk is worn. Pedestrian

signage is located on both sides of the mainline crosswalk. Advanced motorist warning signs for the crosswalks are located approximately 700 feet to the north and 525 feet to the south. The edge of road consists of curb and gutter. There are no existing treatments to the crosswalks.

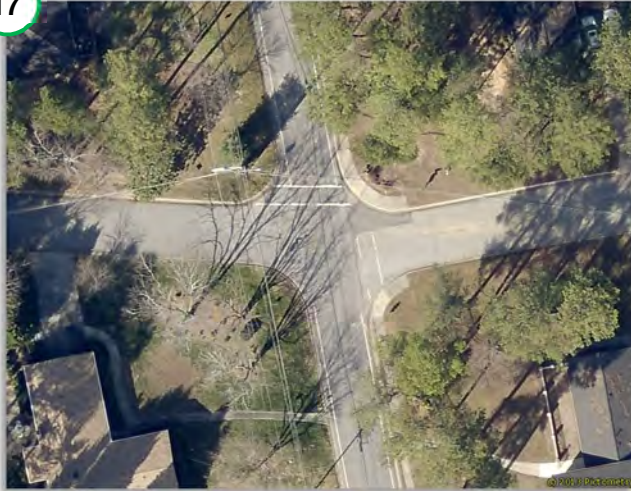
17

Vermack Road at Parliament Drive

The intersection at Vermack Road and Parliament Drive is located in the southwest quadrant of Dunwoody (#17: See *Figure 2*). There are existing sidewalks on the east side of Vermack Road. The current crosswalk striping is worn. Pedestrian signage is located on both sides of the Vermack Road crosswalk. There is an advanced motorist warning sign approximately 380 feet to the south of the mainline crosswalk, facing the northbound approach. The edge of road consists of curb and gutter. There are no existing treatments to the crosswalks.

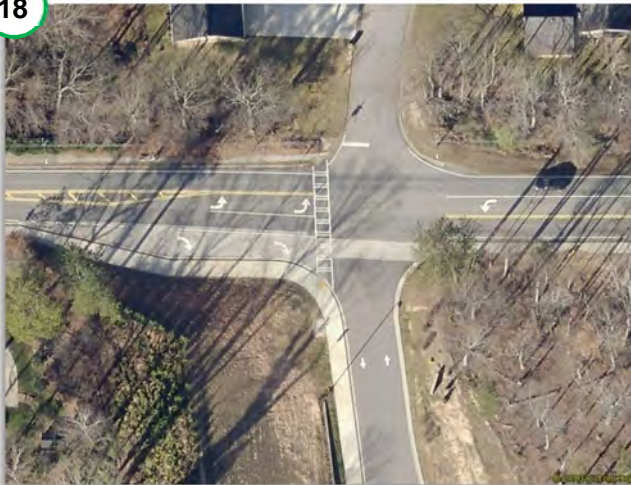
18

Womack Road at Lakeland Woods Court

The intersection at Womack Road and Lakeland Woods Court is located in the southeast quadrant of Dunwoody (#18: See *Figure 2*). There are existing sidewalks on the south side of Womack Road and on the north side, west of the intersection. There is a 2-foot grass buffer between the road and the north sidewalk. The current crosswalk striping is in good condition; however, there is no striping for the south side crosswalk. Pedestrian signage is located on both sides of the crosswalk. There is an advanced motorist warning sign approximately 150 feet west of the crosswalk for the eastbound approach, but there is not a warning sign for the westbound approach. There also is and

in street pedestrian sign and a crossing guard present during school arrival and dismissal. The edge of road consists of curb and gutter along the north side of Chamblee Dunwoody Road and shoulder along the south side. Sight distance is limited on the eastbound approach due to the vertical alignment of the road. On the northwest corner of the intersection, the grade of the ramp appears to be too steep to be ADA compliant.

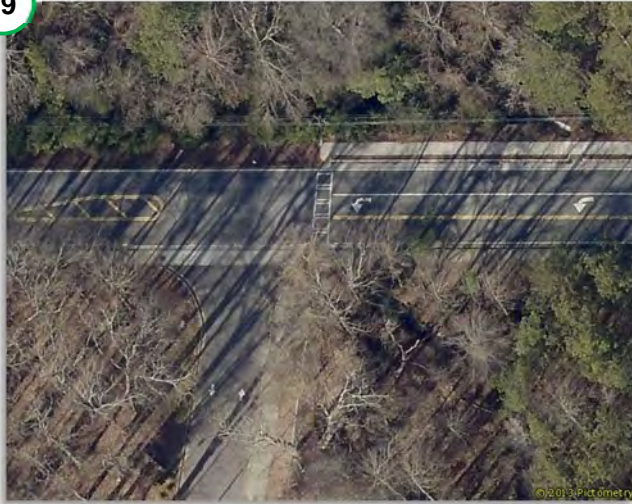
19

Womack Road at Dunwoody Elementary School Driveway

The intersection at Womack Road and the Dunwoody Elementary School driveway is located in the southeast quadrant of Dunwoody (#19: See Figure 2). There are existing sidewalks on both sides of Womack Road. The current crosswalk striping is in fair condition. Pedestrian signage is located at the crosswalk on both sides of the roadway. An advanced motorist warning sign is only present for the westbound approach, approximately 450 feet east of the crosswalk. The edge of road consists of curb and gutter. There are no existing treatments to the crosswalks.

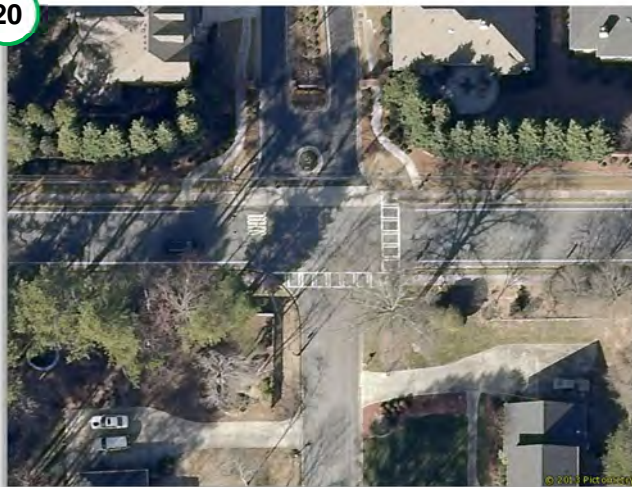
20

Womack Road at Mill Stream Court

The intersection at Womack Road and Mill Stream Court is located in the southeast quadrant of Dunwoody (#20: See Figure 2). There are existing sidewalks on both sides of Womack Road with 2-foot grass buffers from the roadway. The current crosswalk striping is in good condition. Pedestrian signage is located at the crosswalk on both sides of the roadway; however, the sign on the north

side of the crosswalk presents a sight issue for pedestrians. There are not advanced motorist warning signs on either Womack Road approach to the crosswalk. The edge of road consists of curb and gutter with a 1-foot-wide shoulder in the pavement. There are no existing treatments to the crosswalks, but there is a flashing beacon for the 25 mph School Zone just west of the intersection.

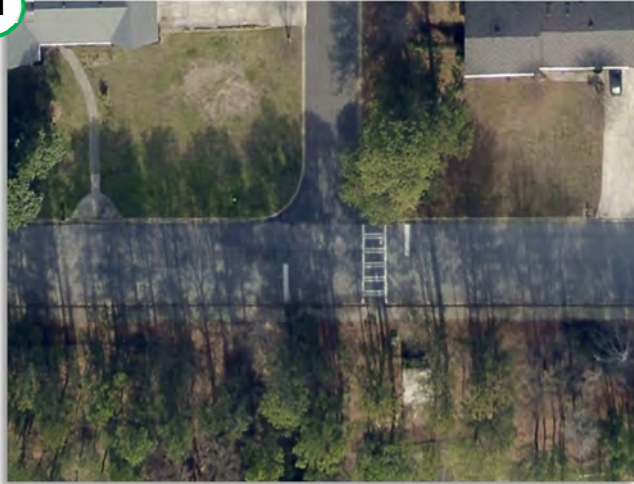
21

Vanderlyn Drive at Hensley Drive

- Nearby School:** Vanderlyn Elementary School
- Land Use:** Residential/Recreational
- Posted Speed:** 25 mph
- Number of Lanes:**
 - Vanderlyn Drive – 2
 - Hensley Drive – 2
- Vehicular ADT:** 3,883 vehicles/day
- Peak Hour AM (PM) Pedestrian Volumes:** 6 (24)
- ADA Compliance:** No (N); Yes (with domes)
- Sight Distance:** Sufficient
- Lighting:** Sufficient

The intersection at Vanderlyn Drive and Hensley Drive is located in the northeast quadrant of Dunwoody (#21: See Figure 2). There is existing sidewalk on the south side of Vanderlyn Drive paralleling the Vanderlyn Elementary School property. The current crosswalk striping is in good condition. There is no pedestrian signage located at the crosswalk on either side of the roadway. There are no advanced motorist warning signs for the crosswalk. A crossing guard is present during school arrival and dismissal. The edge of road consists of curb and gutter. There are no existing treatments to the crosswalks.

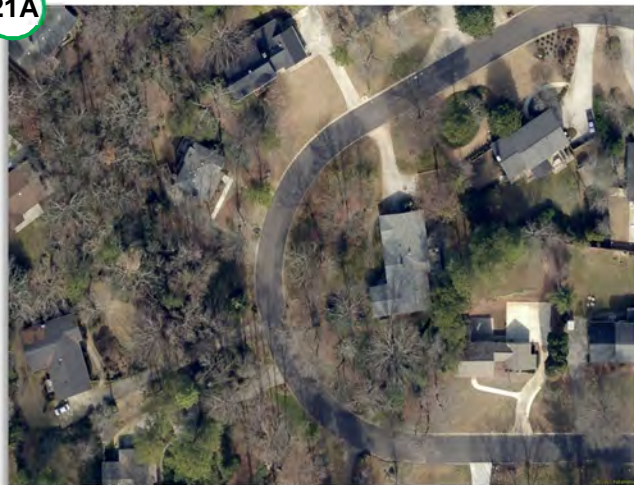
21A

Mid-Block of Hensley Drive

- Nearby School:** Vanderlyn Elementary School
- Land Use:** Residential/Recreational
- Posted Speed:** 25 mph
- Number of Lanes:**
 - Hensley Drive - 2
- Vehicular ADT:** n/a
- Peak Hour AM (PM) Pedestrian Volumes:** 6 (24)
- ADA Compliance:** No
- Sight Distance:** Limited
- Lighting:** Insufficient

Hensley Drive is located in the northeast quadrant of Dunwoody and is near Vanderlyn Elementary School (#21: See Figure 2). There are no existing sidewalks on either side of Hensley Drive. There are no striped crosswalks along the corridor. The edge of road consists of curb and gutter along both sides of Hensley Drive. The sight distance when crossing is limited due to the horizontal and vertical alignment of the roadway.

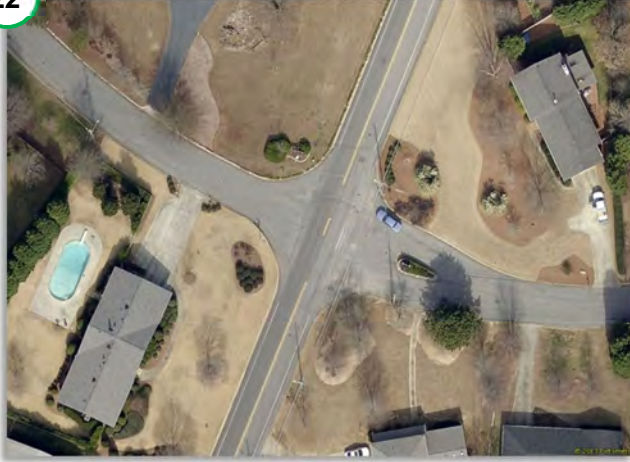
22

Happy Hollow Road at Fontainebleau Drive

- Nearby School:** None
- Land Use:** Residential
- Posted Speed:** 35 mph
- Number of Lanes:**
 - Happy Hollow Road – 2
 - Fontainebleau – 2
- Vehicular ADT:** 3,223 vehicles/day
- Peak Hour AM (PM) Pedestrian Volumes:** 16 (5)
- ADA Compliance:** No
- Sight Distance:** Sufficient
- Lighting:** Sufficient

The intersection at Happy Hollow Road and Fontainebleau Drive is located in the northeast quadrant of Dunwoody (#22: See *Figure 1*). There is an existing sidewalk on the east side of Happy Hollow Road. There are no crosswalks or advanced motorist warning signs for pedestrians. The edge of road consists of curb and gutter with bike lanes.

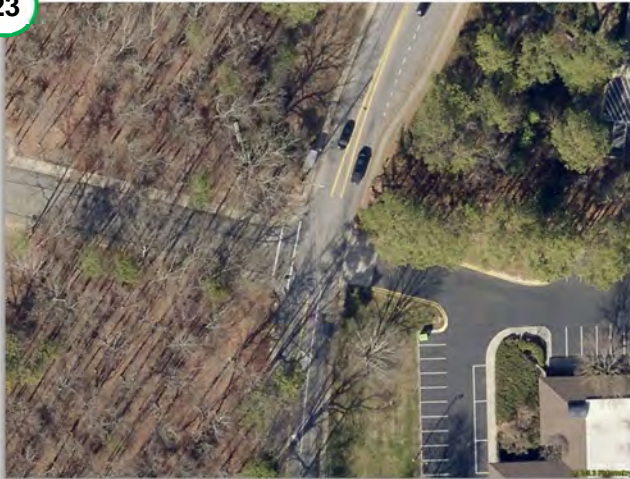
23

North Peachtree Road at Brook Run Avenue/Georgia Way South

- Nearby School:** Chesnut Elementary School
- Land Use:** Residential
- Posted Speed:** 35 mph
- Number of Lanes:**
 - North Peachtree Road – 3 (including northbound left-turn lane)
 - Brook Run Avenue – 2
- Vehicular ADT:** 11,799 vehicles/day
- Peak Hour AM (PM) Pedestrian Volumes:** 0 (1)
- ADA Compliance:** Yes (W, no domes); No (E)
- Sight Distance:** Limited
- Lighting:** Sufficient

The intersection at North Peachtree Road and Brook Run Avenue is located in the southeast quadrant of Dunwoody (#23: See *Figure 1*). There are existing 4-foot-wide sidewalks on both sides of North Peachtree Road. There is a 2-foot sidewalk buffer on the east side of the roadway. The only striped crosswalk that exists just connects north and south of the intersection on the east side and is worn. There are no pedestrian or advanced motorist warning signs for the intersection. The edge of road consists of curb. There are no existing treatments to the crosswalks.

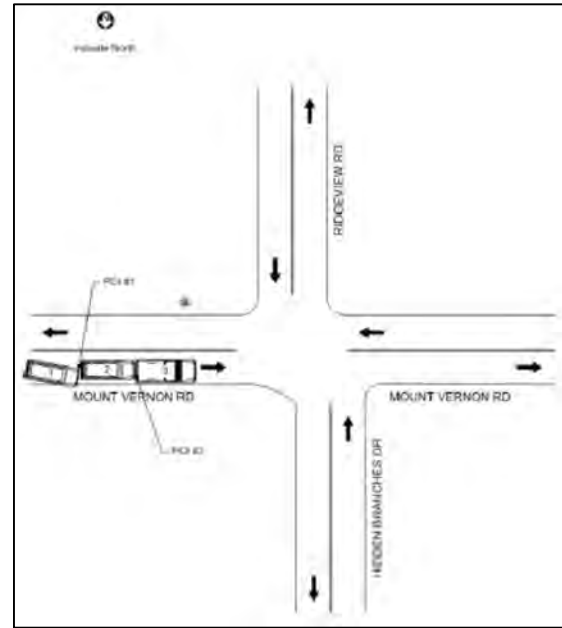
Mount Vernon Road between Ridgeview Road and Trailbridge Drive: “Vehicles 1, 2, and 3 were traveling west on Mount Vernon Road approaching the pedestrian crossing near Ridgeview Road. Vehicle 1 was directly behind Vehicle 2, which was directly behind Vehicle 3. Vehicle 2 and 3 stopped in the roadway for a pedestrian who activated the flashing yellow light. Driver 1 failed to stop in time and struck the rear of Vehicle 2. Vehicle 2 was pushed forward into the rear of Vehicle 3. The driver of vehicle 1 was cited for following too close.”

Figure 3. Crash Diagram

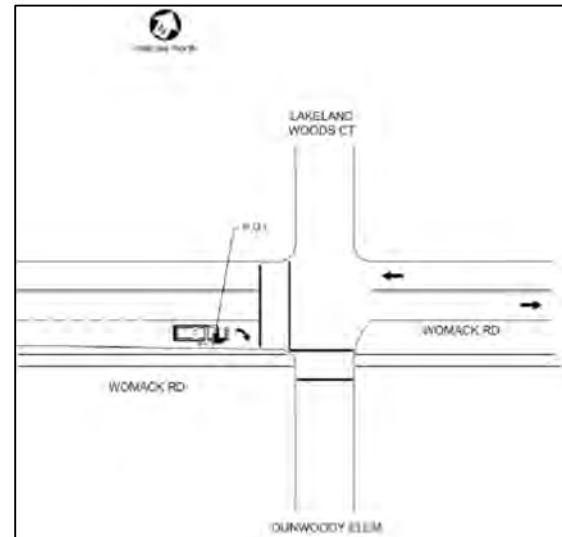
Womack Road at Lakeland Wood Court: “Vehicle 1 was traveling east on Womack Road in the right turn lane into Dunwoody Elementary School. Pedestrian 1 (Crossing Guard) came from the south sidewalk area with his handheld stop sign up for Vehicle 1 to stop. Vehicle 1 stopped, proceeded to go and struck the left foot/knee area of the crossing guard. The crossing guard was treated at the scene by DeKalb Rescue 18 for a complaint of left foot/knee pain but refused to be transported to the hospital.”

Figure 4. Crash Diagram

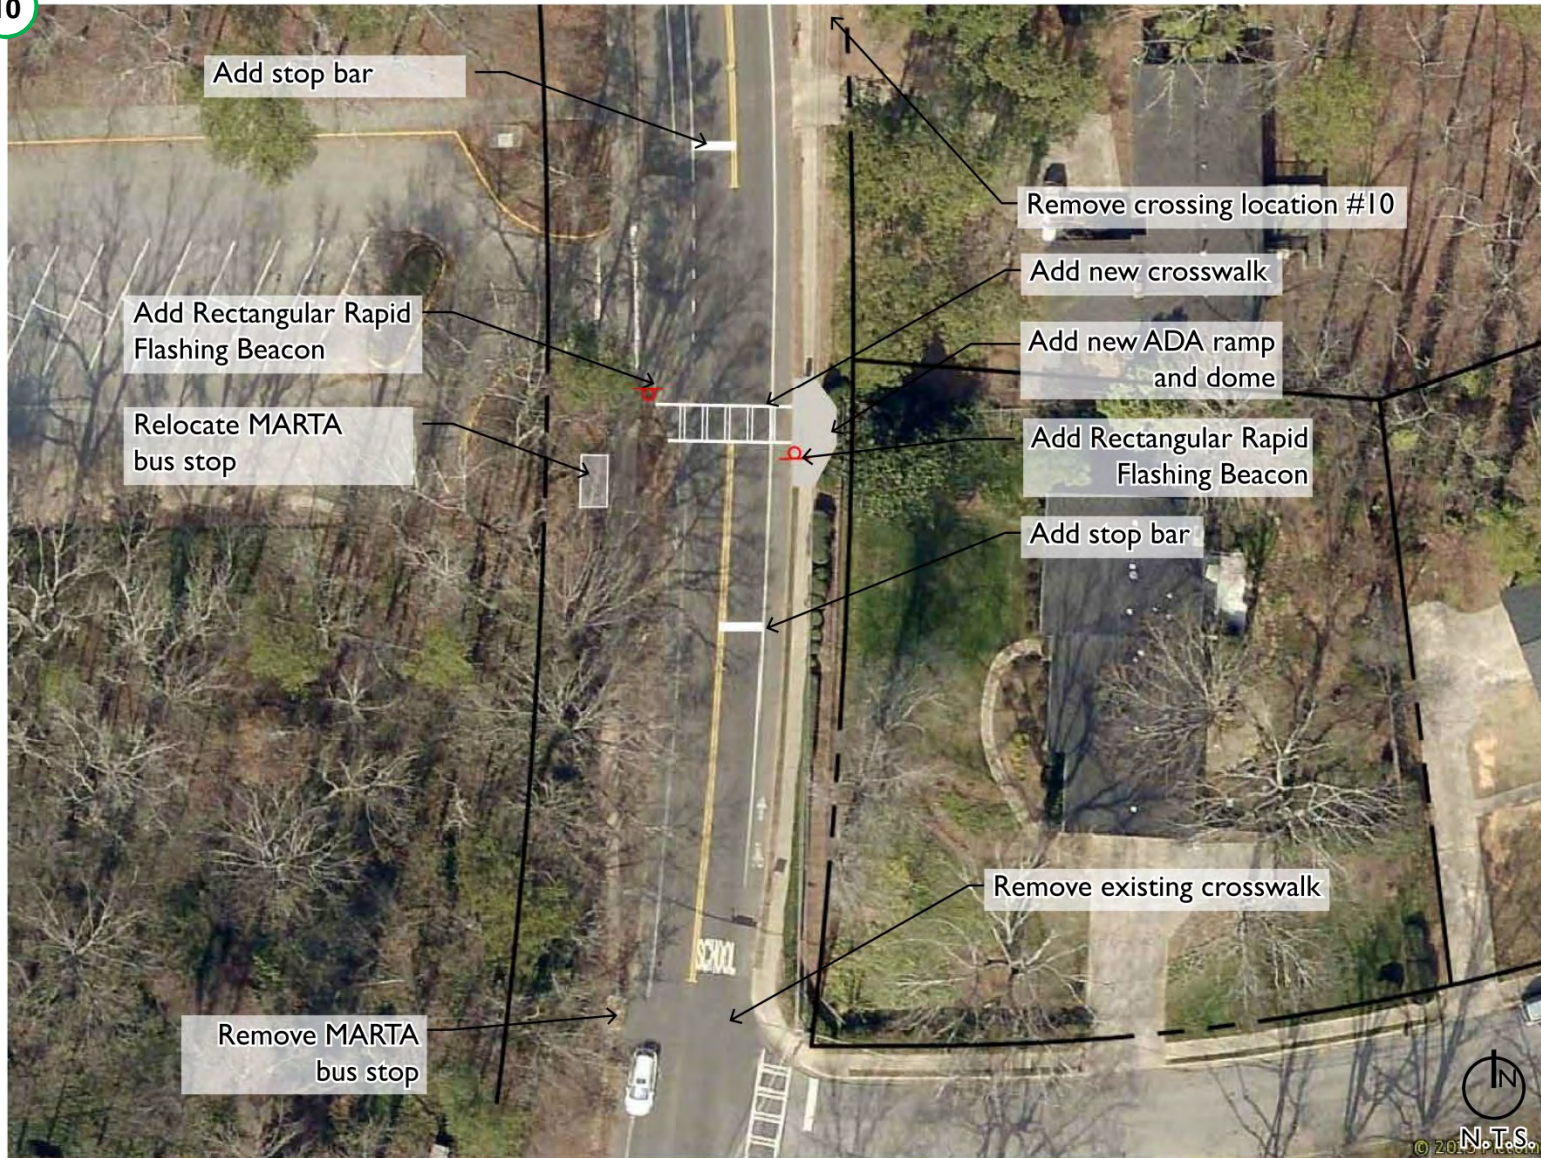
Figure 5. North Peachtree Road between Peachford Road and Brookhurst Drive Concept

The ***North Peachtree Road between Peachford Road and Brookhurst Drive (study location #10)*** crosswalk is recommended to be treated with a RRFB and moved to a new location at the south Chesnut Elementary School driveway. The crosswalk received a score “N” from the FHWA analysis based on high traffic volumes on North Peachtree Road with moderate vehicular speeds across three travel lanes. It is also located in front of the Chesnut Charter Elementary School and was identified in the Safe Routes to Schools meeting as unsafe for pedestrians. There is currently a crossing guard at the location during school hours, but additional improvements are necessary. In addition to the RRFB, stop bars are proposed for both directions of traffic. It has been observed that vehicles stop too close to the crosswalk before and after school hours. A sidewalk pad on the east side of North Peachtree Road is proposed to be added because the width of the existing sidewalk does not provide enough space for the high volumes of pedestrians before and after school. Included in this recommendation is the removal of the ***North Peachtree Road at Brookhurst Drive (study location #9)*** crossing, which would also require the relocation of the existing MARTA bus stop. *Figure 4* shows the concept design for this location.

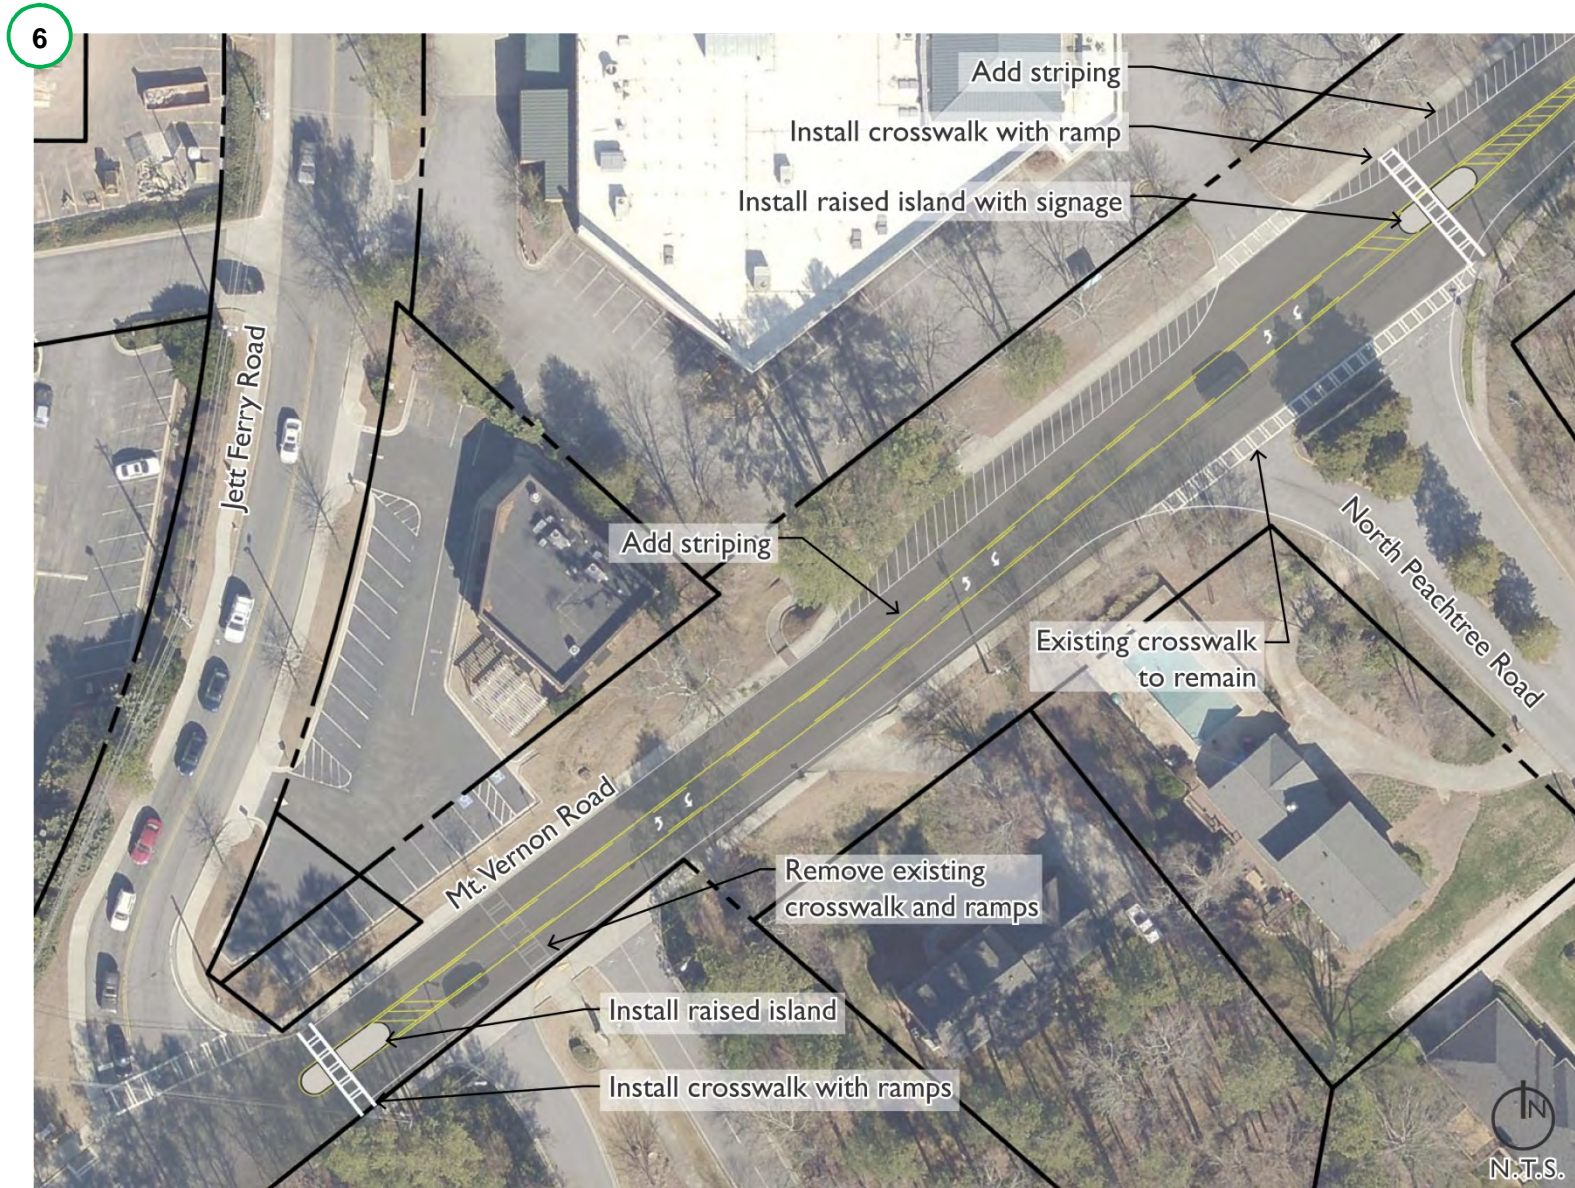
Figure 6. Mount Vernon Road at All Saints Church Driveway Concept

Mount Vernon Road at All Saints Catholic Church Driveway (study location #6) is recommended to be treated with pedestrian refuge islands in two different locations. The crosswalk received a score “P” from the FHWA analysis based on high vehicular traffic volumes with moderate vehicular speeds across three travel lanes. This treatment is warranted due to the high volume of pedestrians that cross Mount Vernon Road before and after church service hours. During most weekends, the parking overflows into parking areas north of Mount Vernon Road, causing pedestrians to cross the heavily traveled road. The width of the road provides the space needed for a pedestrian refuge island in front of the church. The second location is proposed for the three-legged intersection of Mount Vernon Road at North Peachtree Road to provide better access for any church overflow parking and for students walking to Kinglsey Elementary School. As stated before, “Walk to School Wednesdays” has a start location north of Mount Vernon Road. At this location, the existing median on North Peachtree Road could be extended to provide additional pedestrian refuge. This median extension is included in the cost estimate. Additionally, the existing crosswalk should be removed. *Figure 5* shows the concept design for this location.

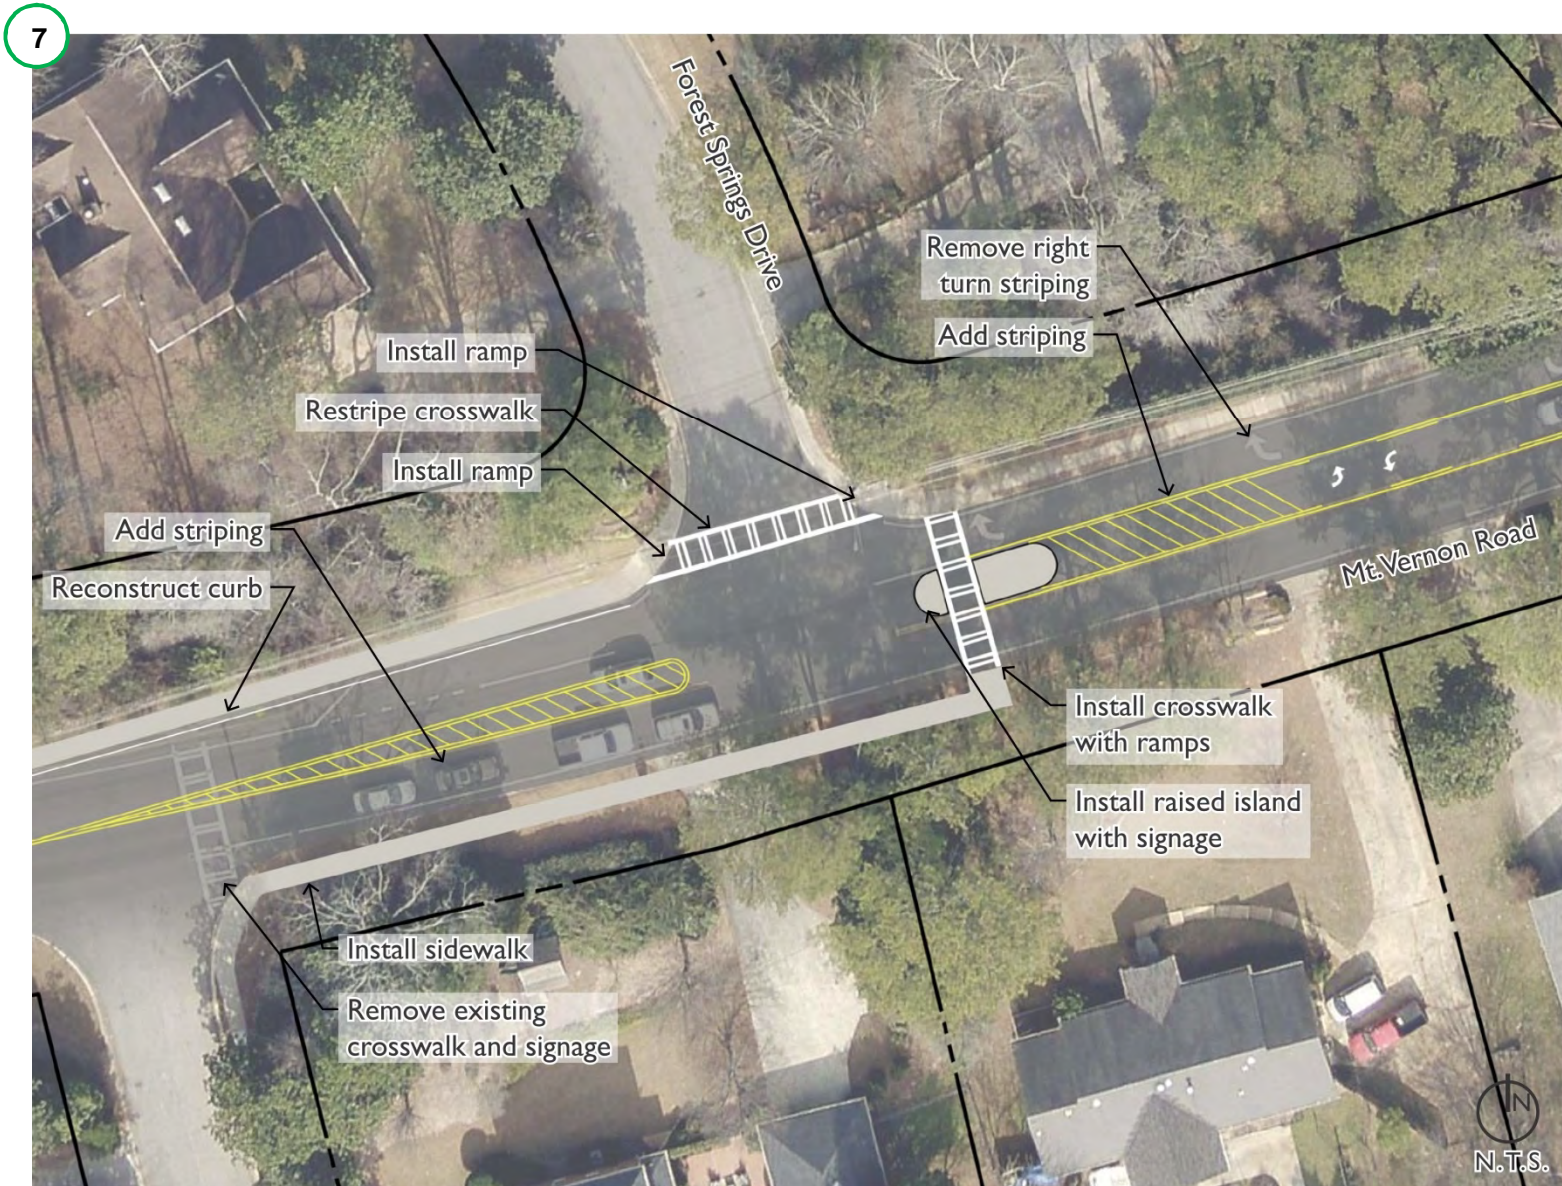
Figure 7. Mount Vernon Road at Stratham Drive Concept

Mount Vernon Road at Stratham Drive (study location #7) is recommended to be treated with a pedestrian refuge island. The crosswalk received a score of “P” from the FHWA analysis based on high vehicular traffic volumes with moderate speeds across two travel lanes. Stratham Drive is also used as a major cut-through location for vehicles and pedestrians traveling to Vanderlyn Elementary School and further south. While there currently is not a high volume of pedestrians using the crosswalk, there were pedestrians on both sides of Mount Vernon Road observed while in the field. Removing the acceleration lane exiting Forest Springs Drive will provide the available space needed to add the refuge island. The crosswalk would be moved east of Forest Springs Drive in order to reduce conflicting traffic volumes. Additionally, a new sidewalk is proposed for
