F I N A L R E P O R T

PEDESTRIAN SAFETY ACTION PLAN

Submitted to: **Dunwoody**
Smart people – Smart city

April 2014
Project # 019124006

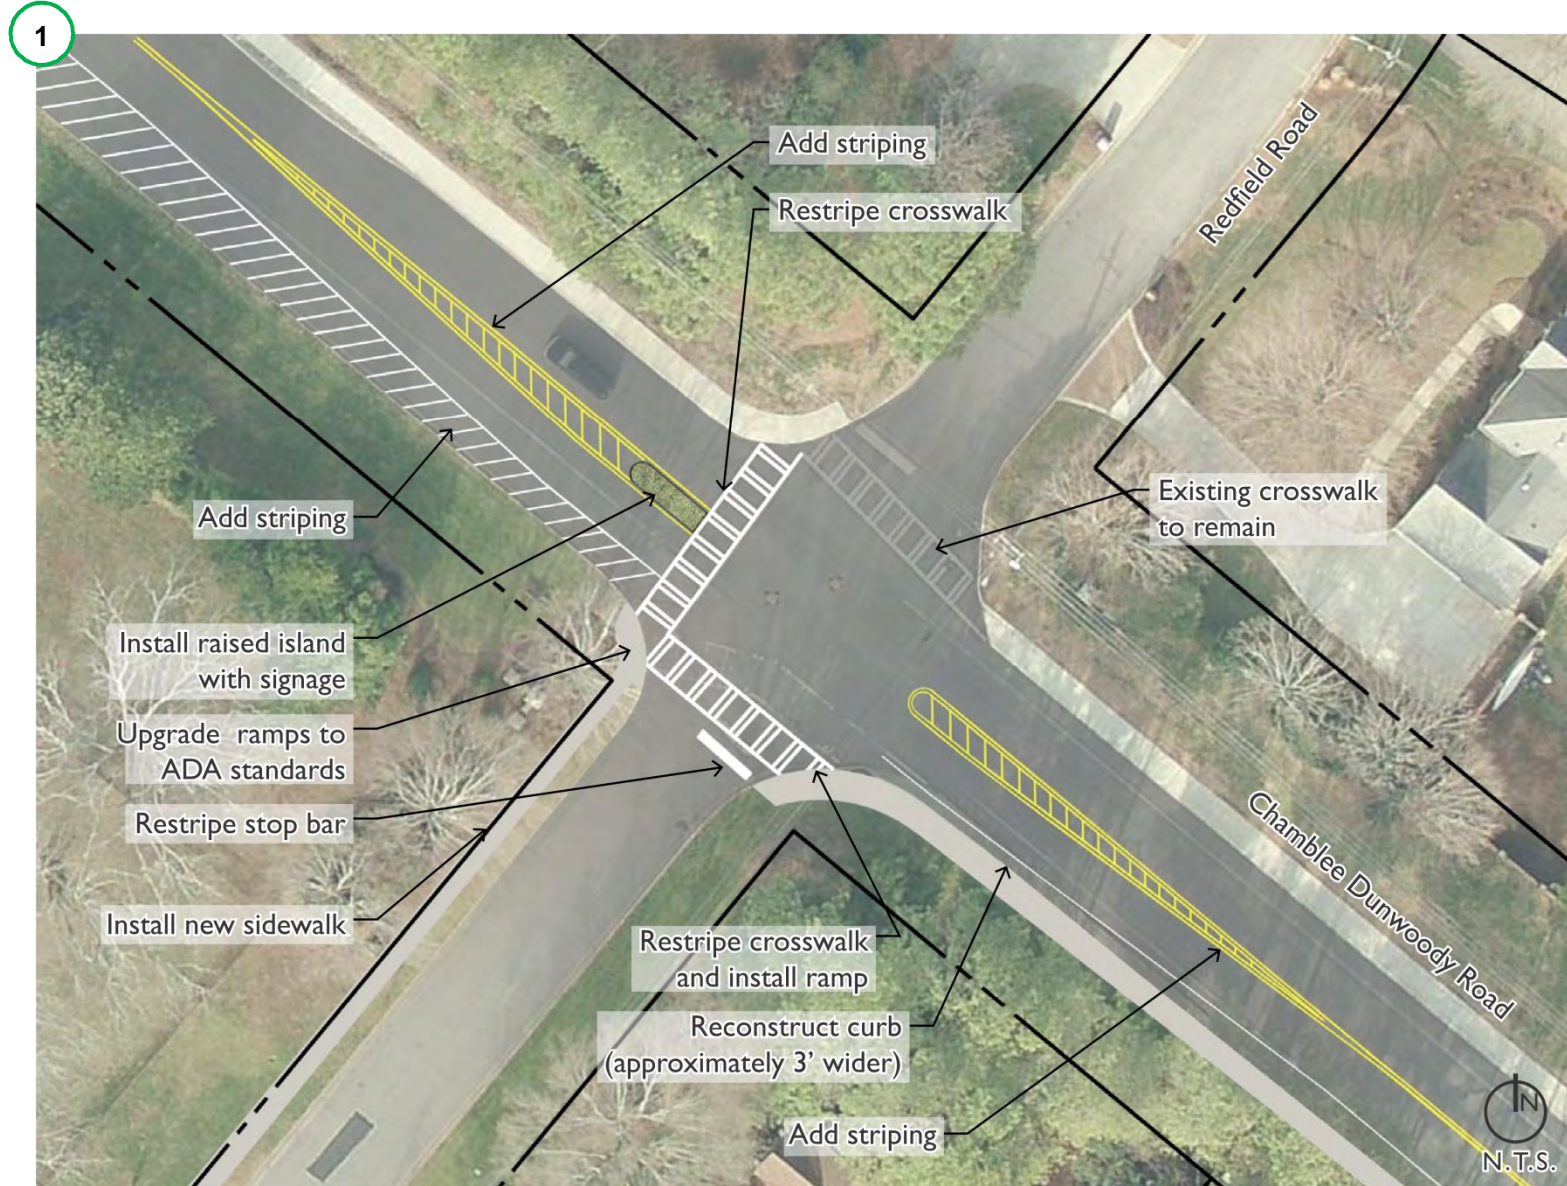
Figure 8. Chamblee Dunwoody Road at Redfield Road Concept

Chamblee Dunwoody Road at Redfield Road (study location #1) is recommended to be treated with a pedestrian refuge island. While the crosswalk received only a score of “C” from the FHWA analysis based on its low traffic volumes with moderate speeds across three travel lanes, there is a high number of pedestrians using the existing crosswalk and it connects the Redfield subdivision. The roadway geometry allows for the necessary space for a refuge island by removing the current southeast-bound deceleration right-turn lane, which is not warranted by the current traffic volumes. Additionally, striping and new sidewalks are proposed to be added to provide safer operations for vehicles and pedestrians. *Figure 7* shows the concept design for this location.

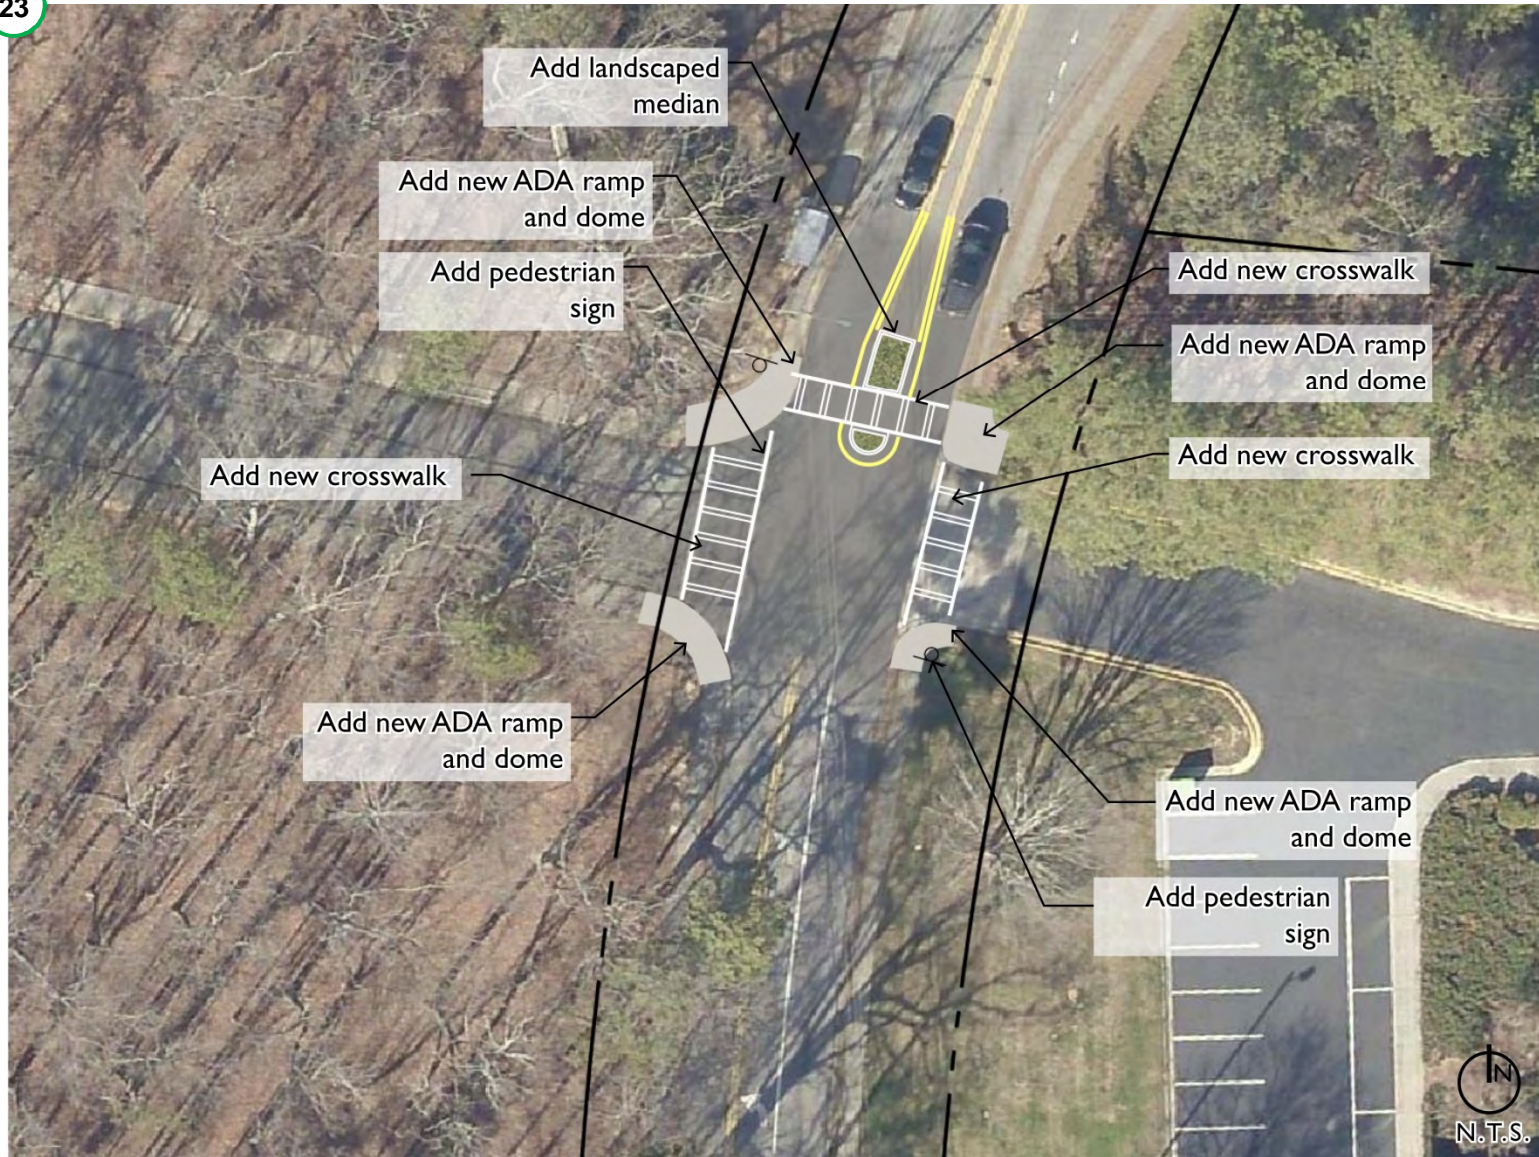
Figure 9. North Peachtree Road at Brook Run Avenue Concept

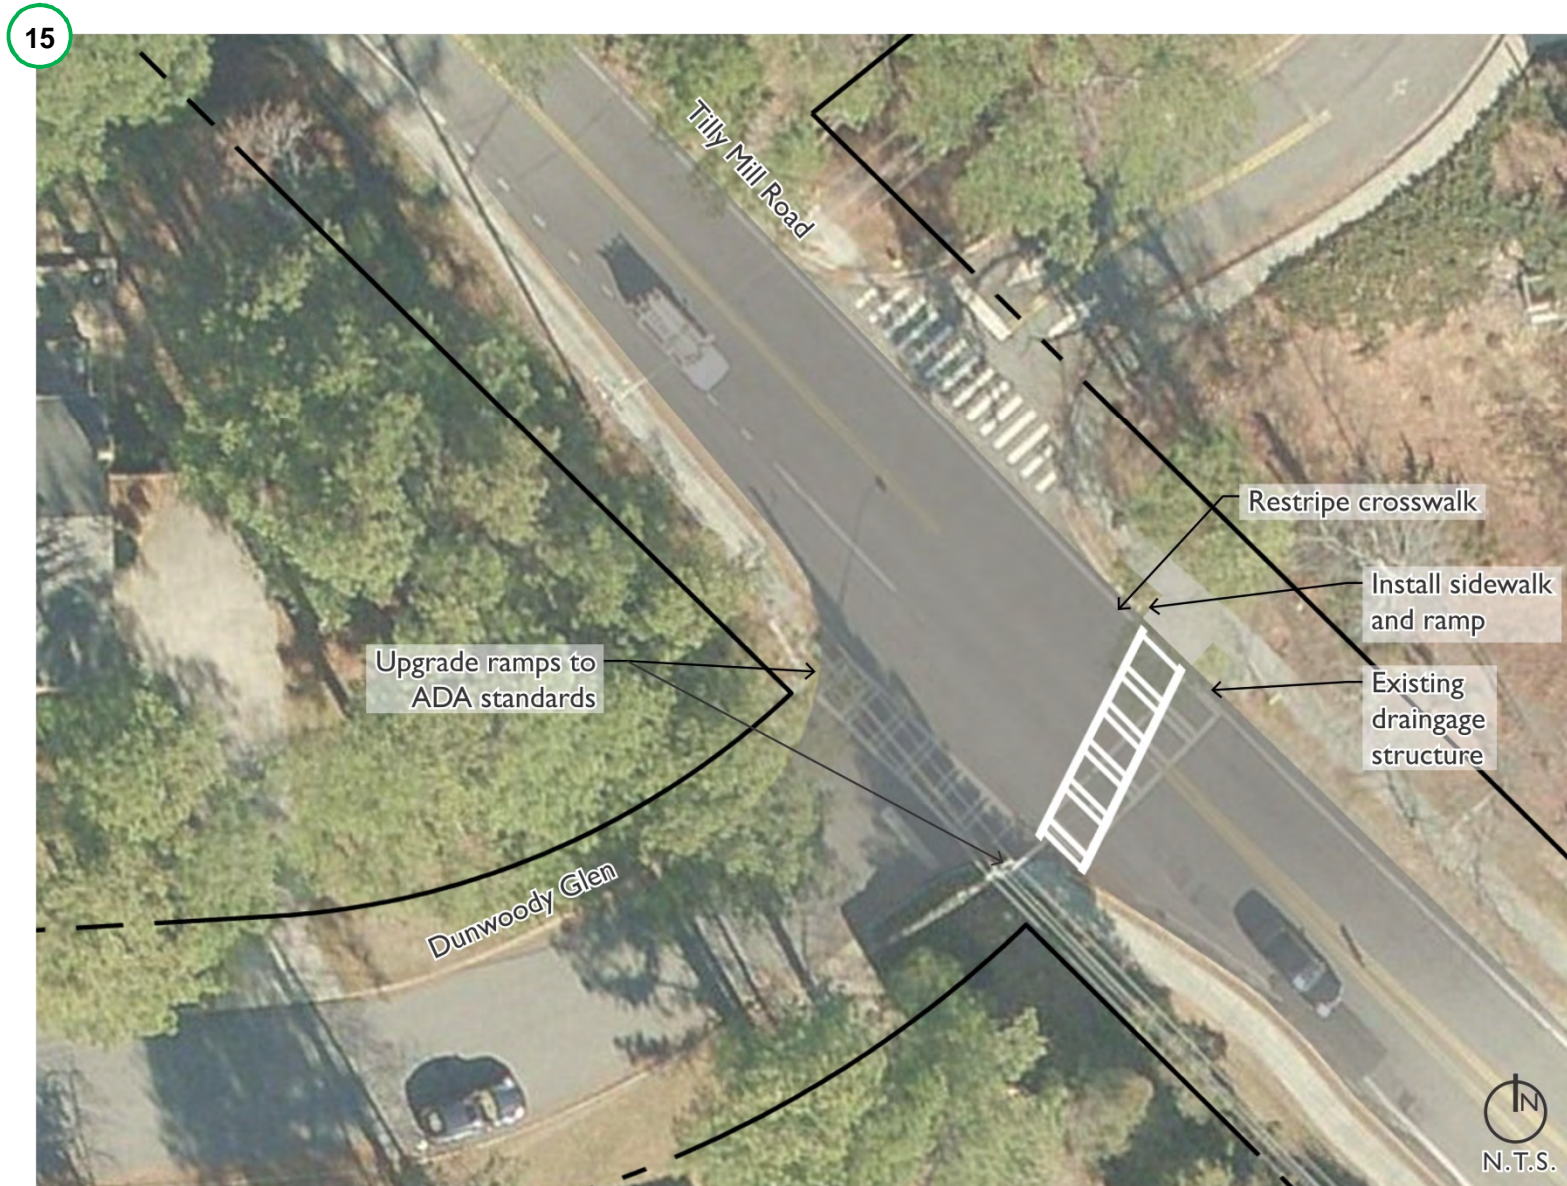
Figure 10. Tilly Mill Road at Dunwoody Glen Concept

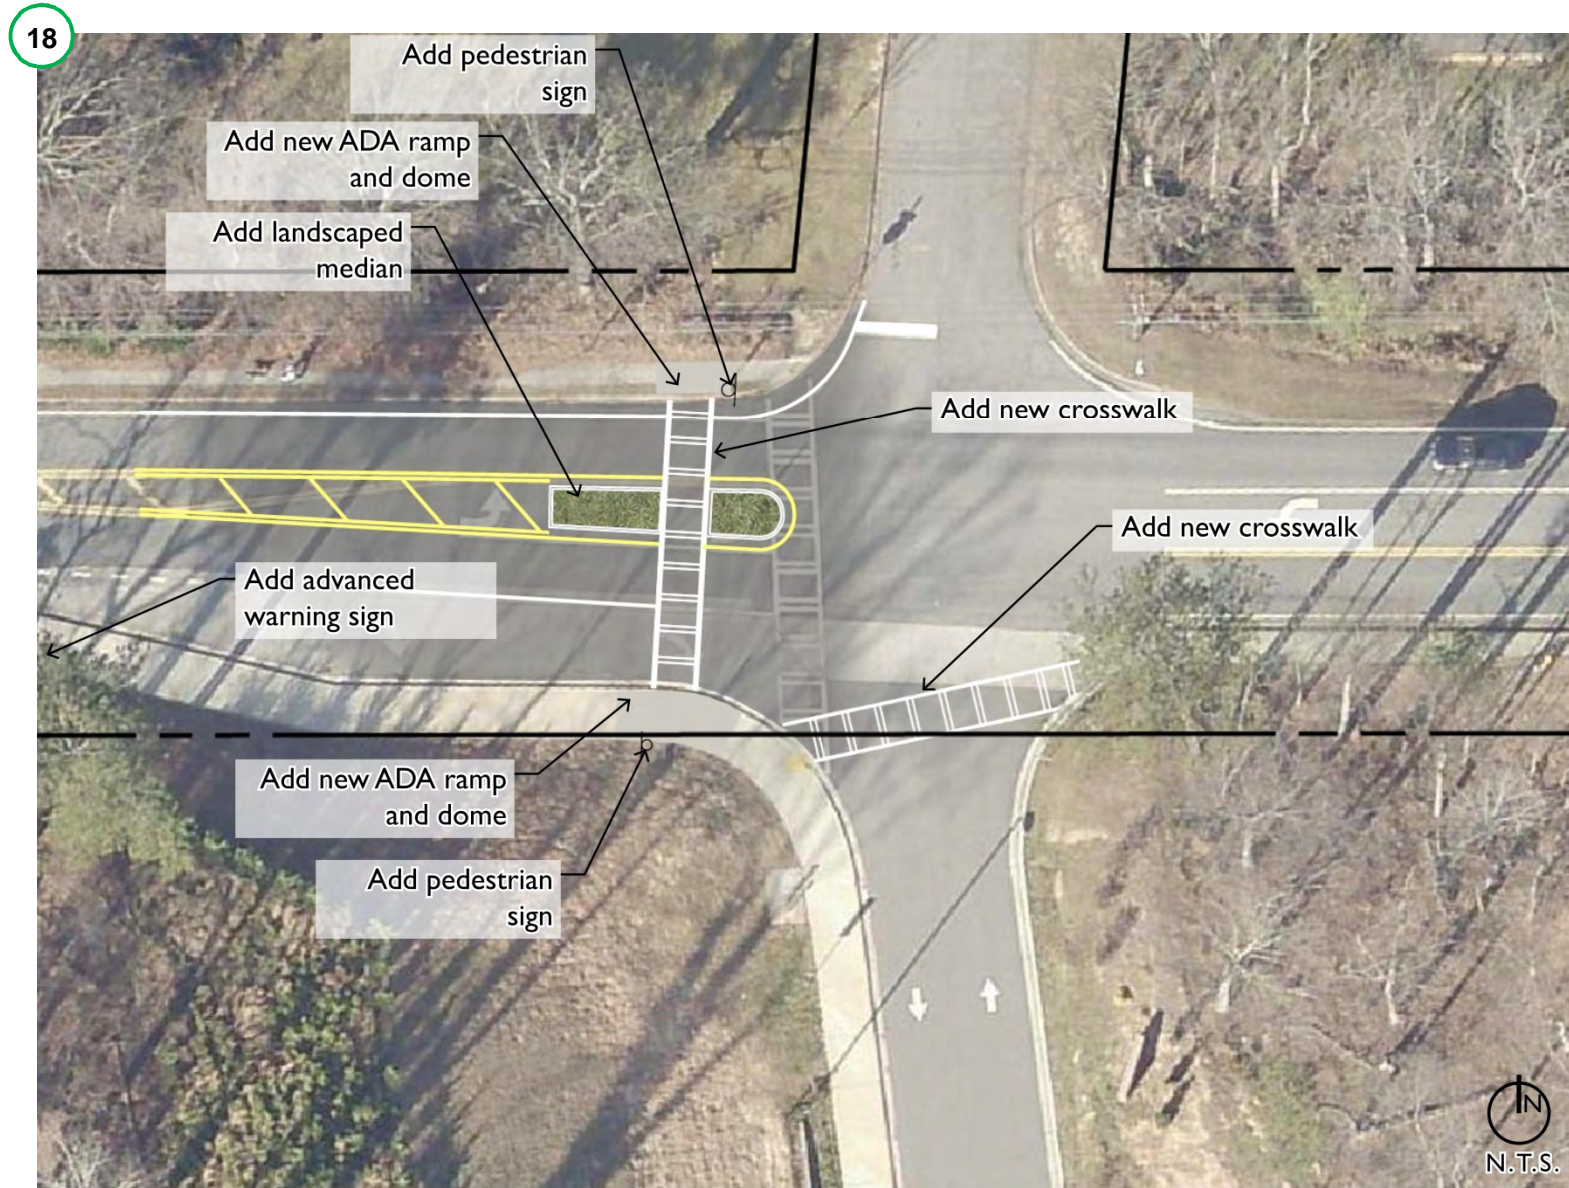
Figure 11. Womack Road at Lakeland Woods Court Concept

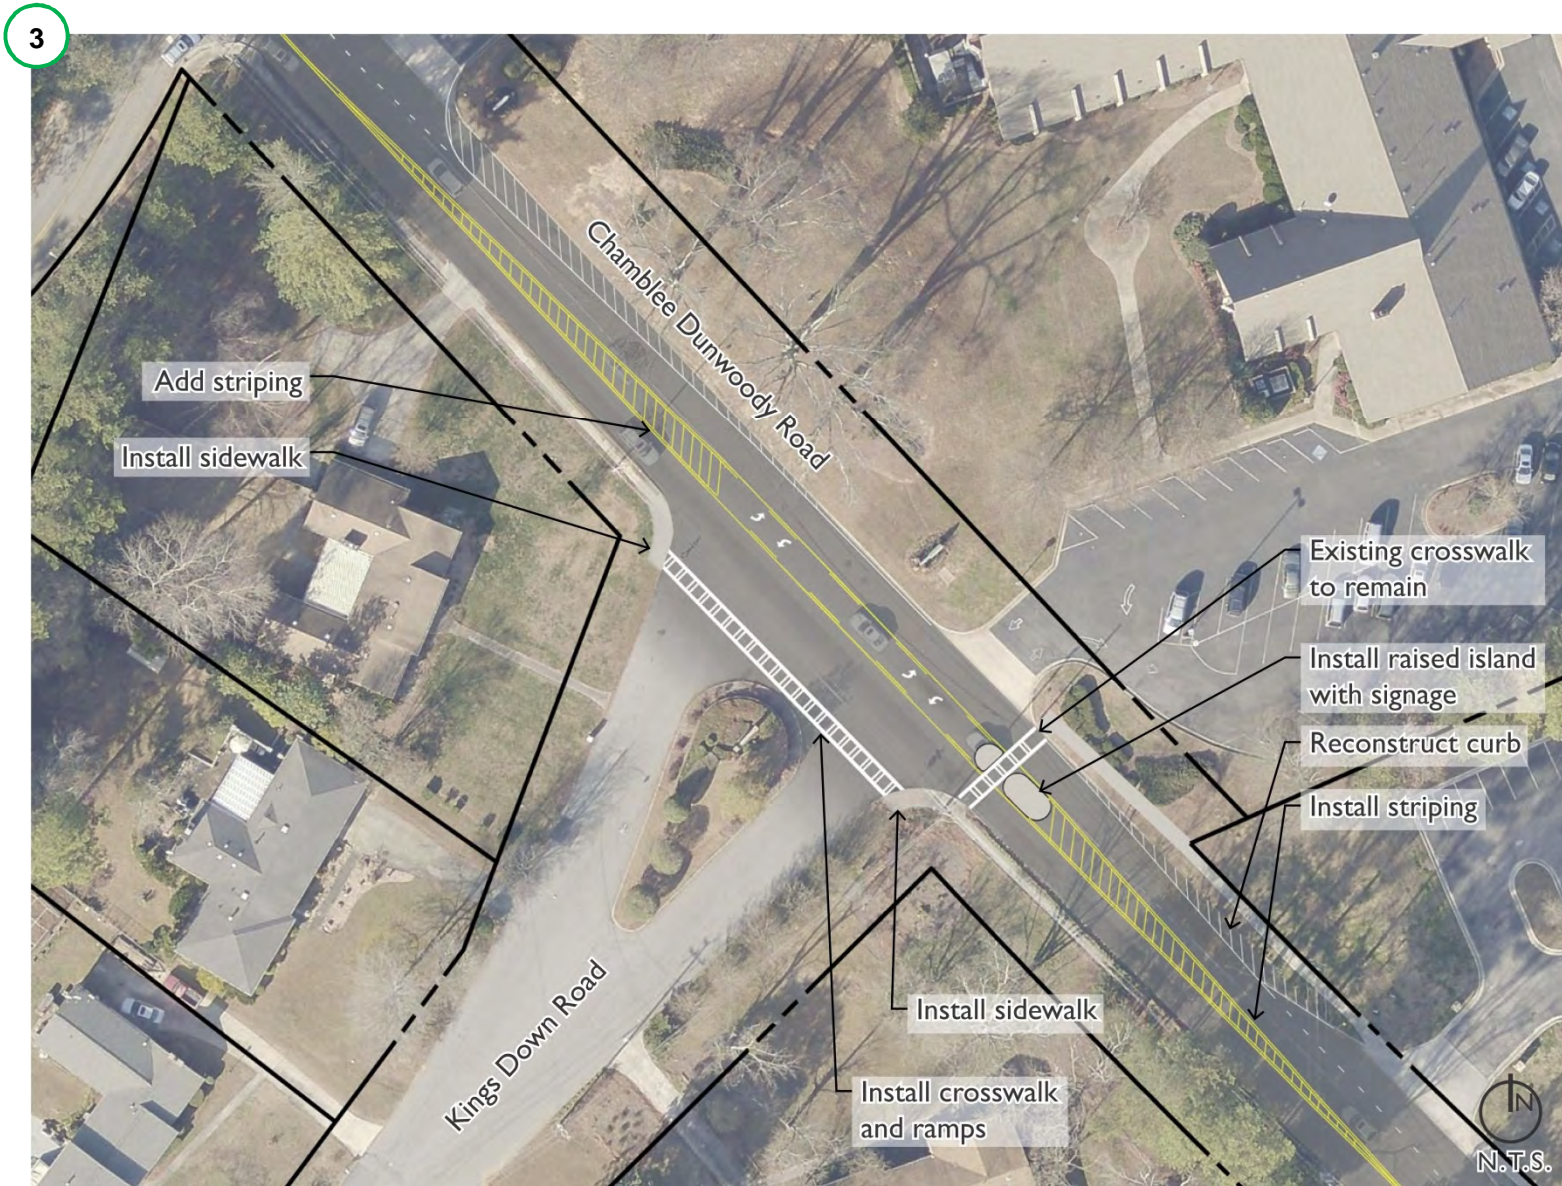
Figure 12. Chamblee Dunwoody Road at Kings Down Road Concept
